# Former Coach House, Newport, Pembrokeshire

## Archaeological Buildings Record & Watching Brief Report

Planning #: **NP/14/0534**

Project #: AD010      25<sup>th</sup> May 2016

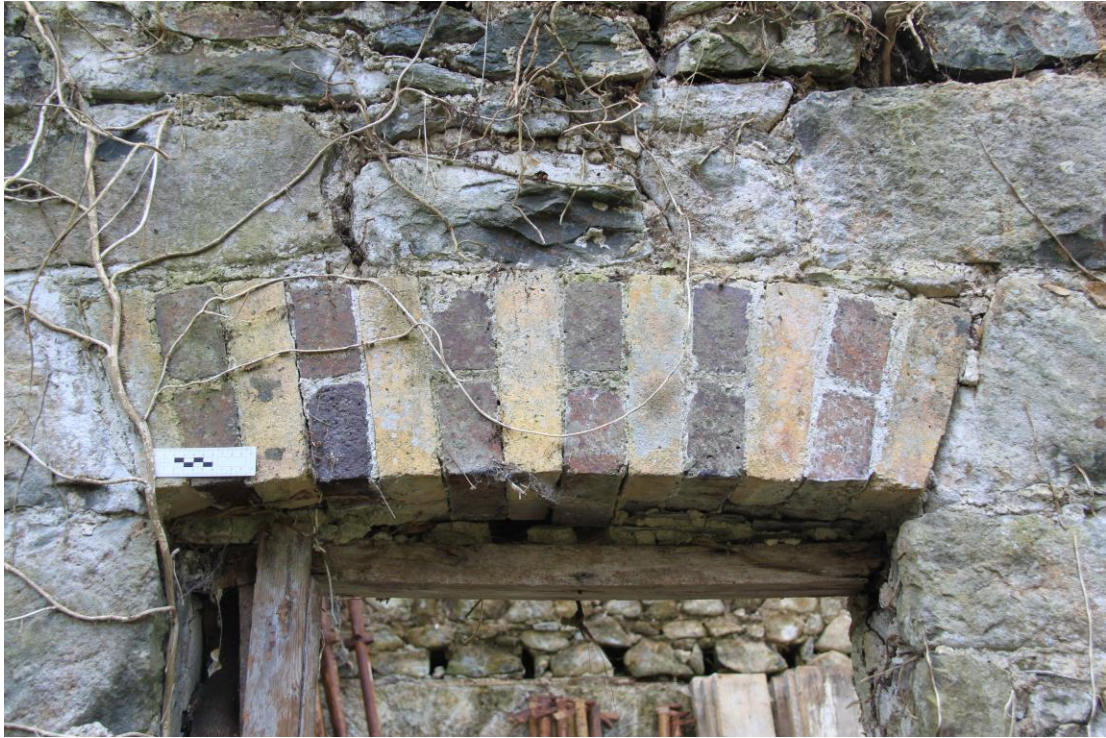
**Plate 13** - AD010-BR-013 - Yellow and red brick flat segmental arch to window head, north elevation.

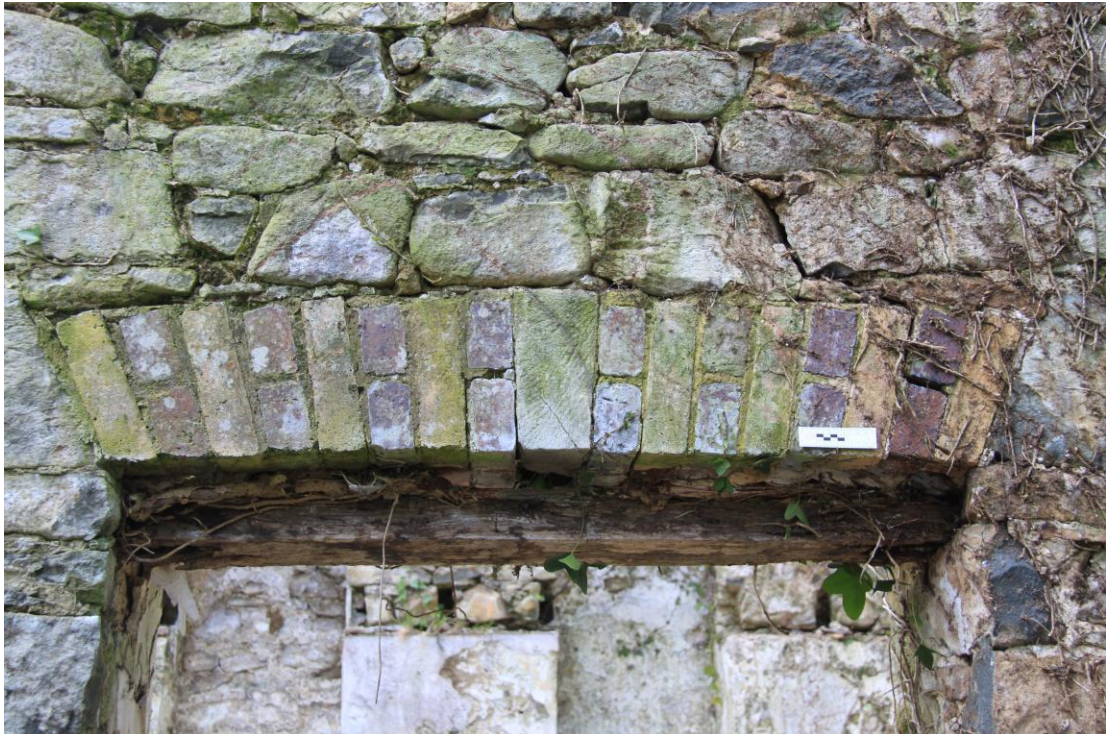
**Plate 14** - AD010-BR-014 - Yellow and red brick flat segmental arch to door head, north elevation.

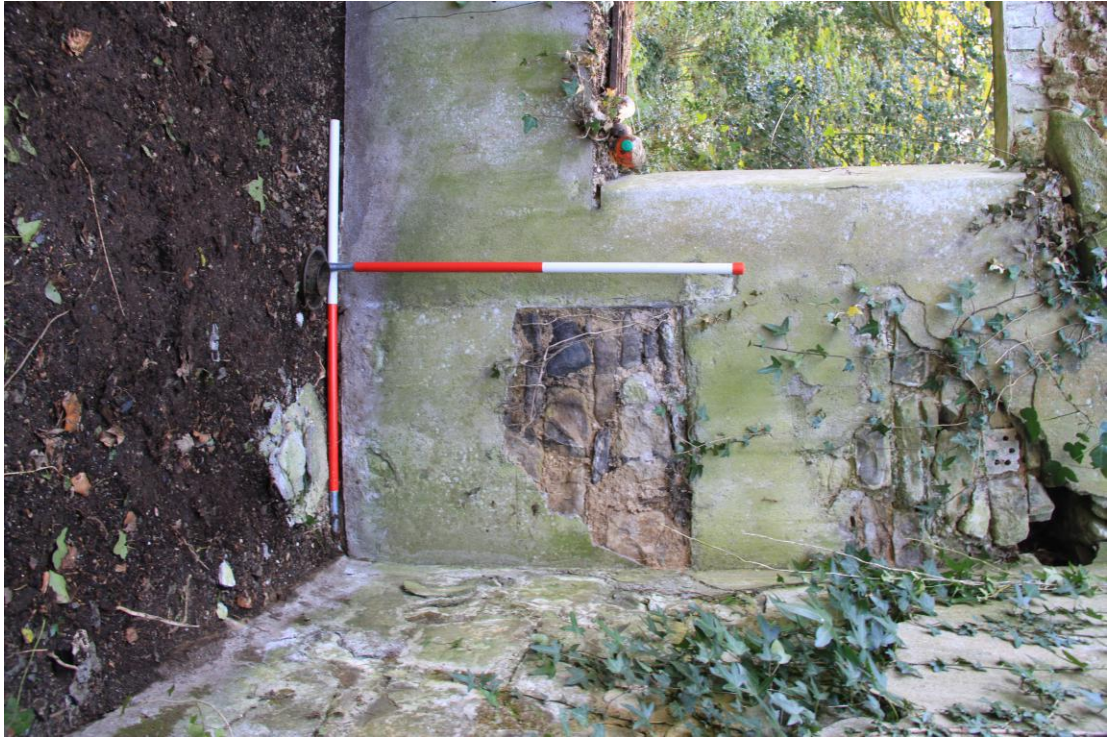
**Plate 33** - AD010-BR-033 - Blocked fireplace, Extension B internal, east wall.

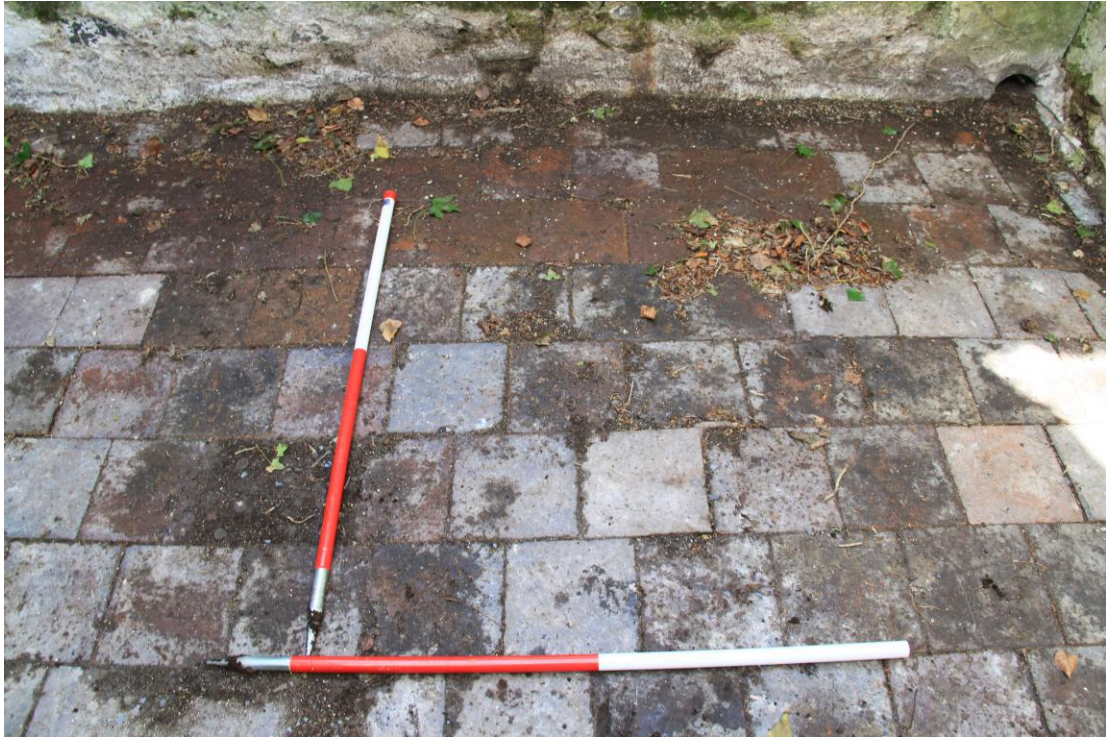
The remains of a small boiler occupies the north-east corner of the room (**Plate 38**) and red quarry tiles cover the floor (**Plate 37**). The two windows and door all have oak lintels internally (**Plates 39-40**). A four light sash window frame remains, but de-glazed and damaged in the east elevation (**Plate 47**).

**Plate 37** - AD010-BR-037 - Quarry tile floor to Extension A.

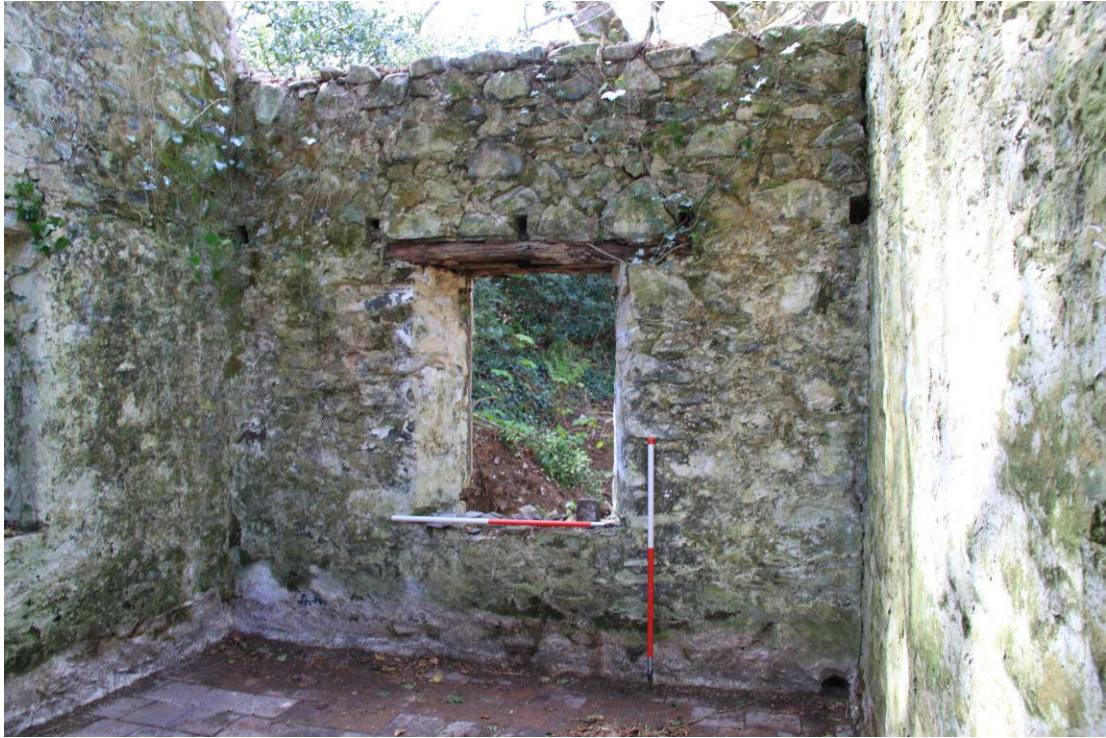
**Plate 39** - AD010-BR-039 - Internal view of Extension B towards the south.

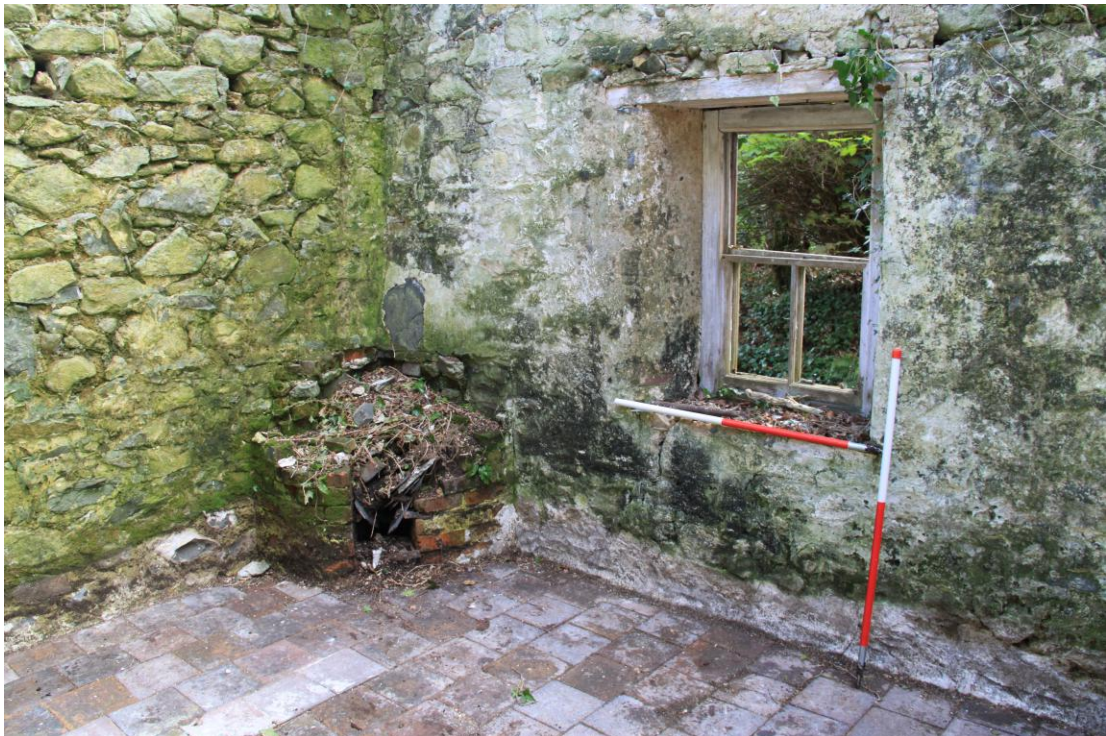
**Plate 40** - AD010-BR-040 - Internal view of Extension B towards the east.

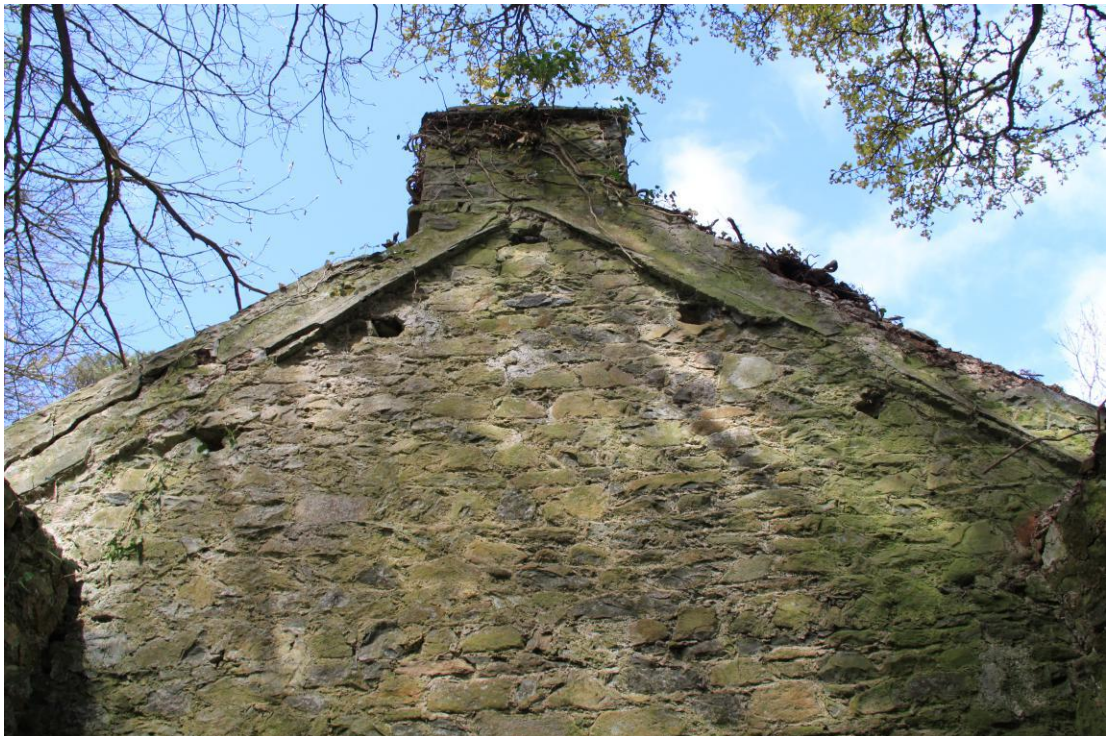
**Plate 44** - AD010-BR-044 - Gable wall between Former Coach House and Extension A, showing two purlin and one ridge sockets.

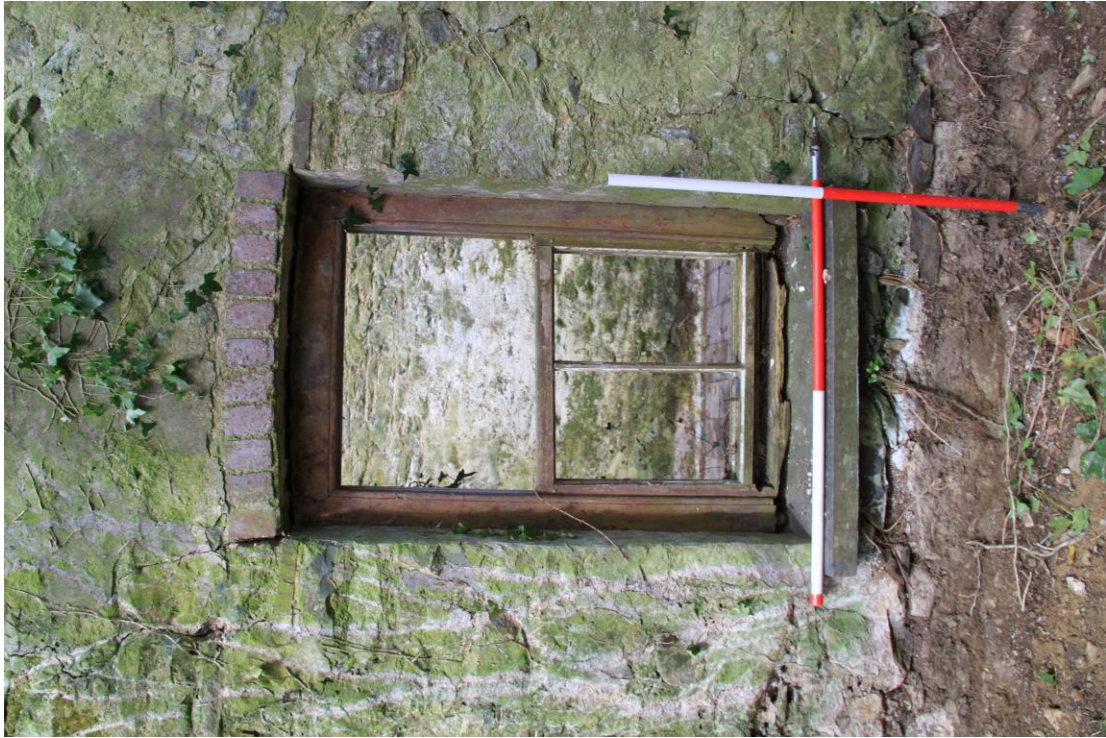
**Plate 47** - AD010-BR-047 - Remains of four light box sash window, Extension A east elevation.

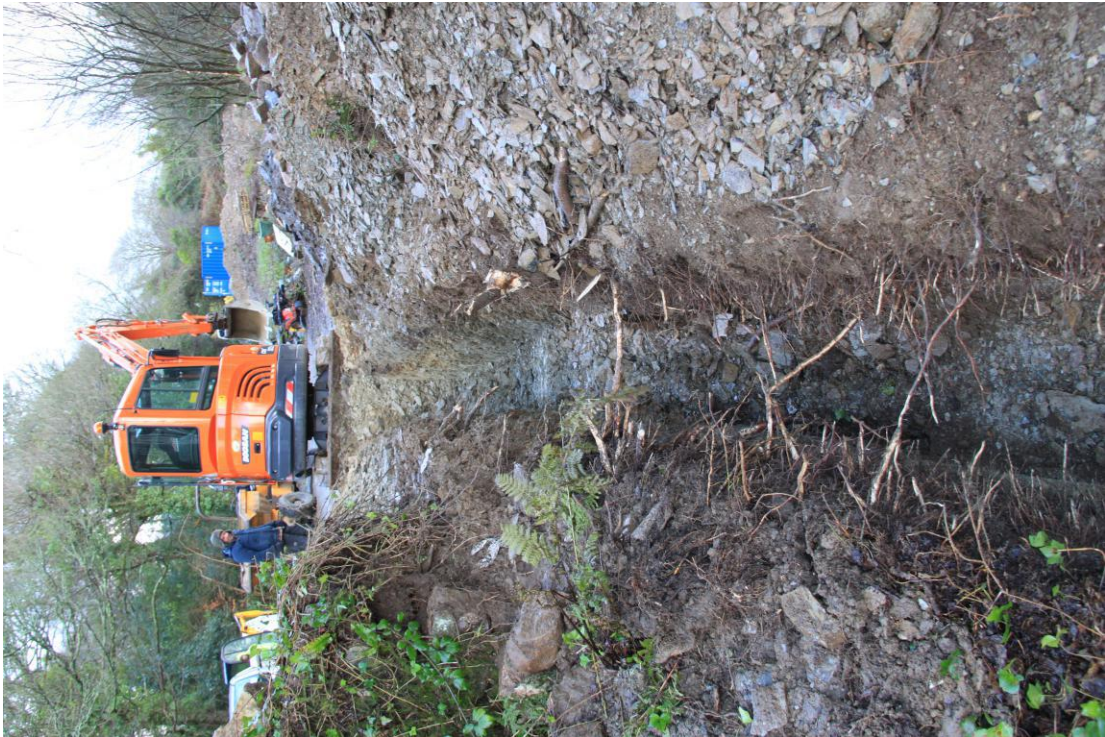
- 8.2.2 The former leat was originally excavated to a depth at which the parent bedrock was reached, no lining material could be identified; a grey silty deposit was identified. Subsequent disuse caused the tumble of the earth banks into the waterway.

**Plate 55** - AD010-D1-008 - Service trench 1 cutting through disused leat.

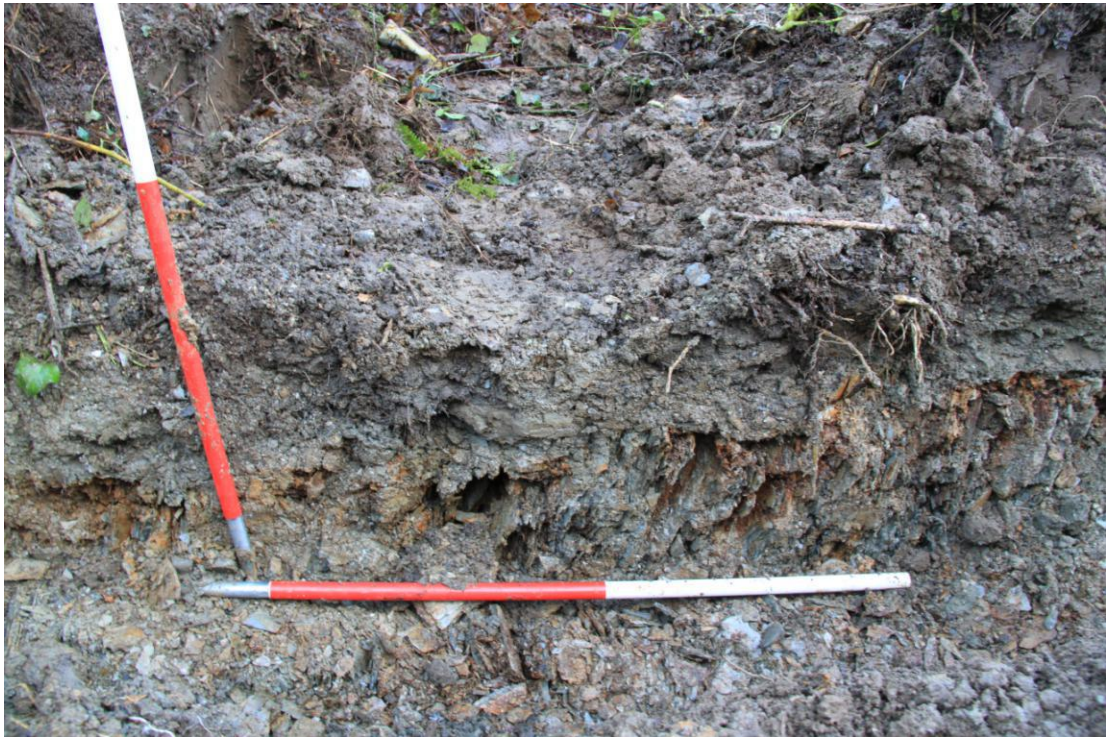
**Plate 63** - AD010-D2-016 - Section of service trench 1 showing leat.

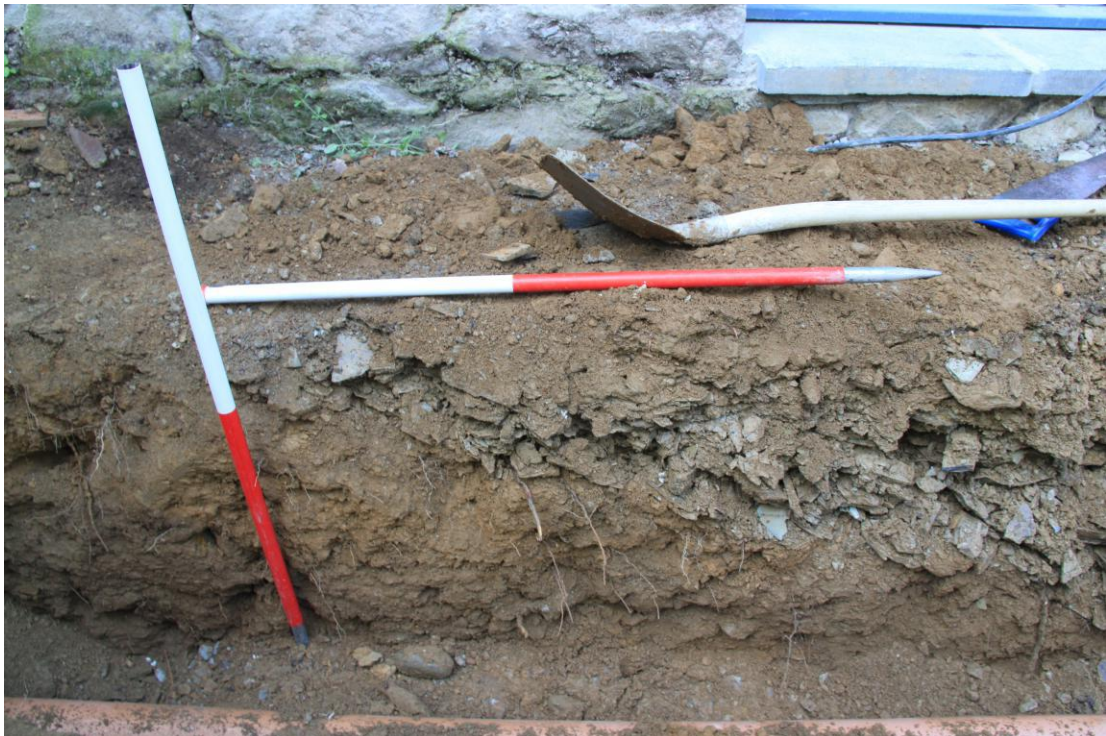
- 7.2.1 The stratigraphic sequence has been disturbed by the levelling of a large area of the site, where cut and scrape had been employed to create a levelled area for the Former Coach House to be built and allow a track-way to be graduated for an approach to the building. This has caused the loss of top and subsoil layers on part of the site and a mixing of both across others, resulting from this, soil depth varied significantly across the site.

**Plate 65** - AD010-D3-018 - Service trench 2 in front of the Former Coach House showing layers of levelling - shale over clayey-loam.
