# Former Coach House, Newport, Pembrokeshire

## Archaeological Buildings Record & Watching Brief Report

Planning #: **NP/14/0534**

Project #: AD010      25<sup>th</sup> May 2016

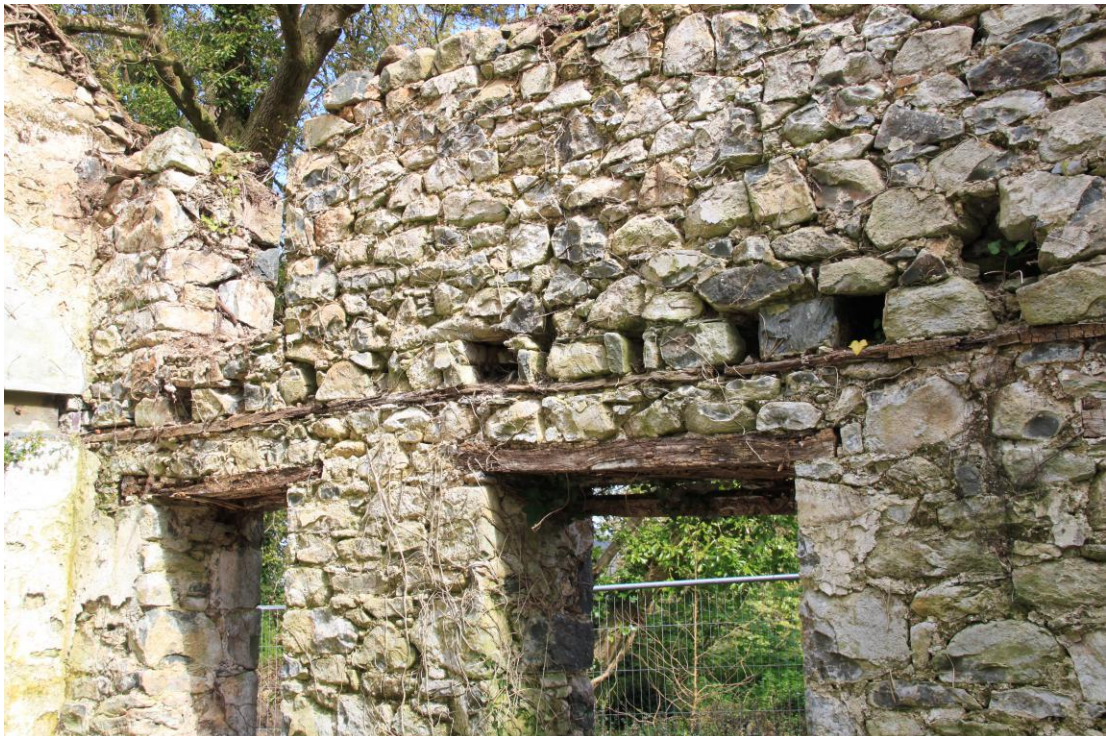
**Plate 18** - AD010-BR-018 - Joist sockets, internal, north wall.

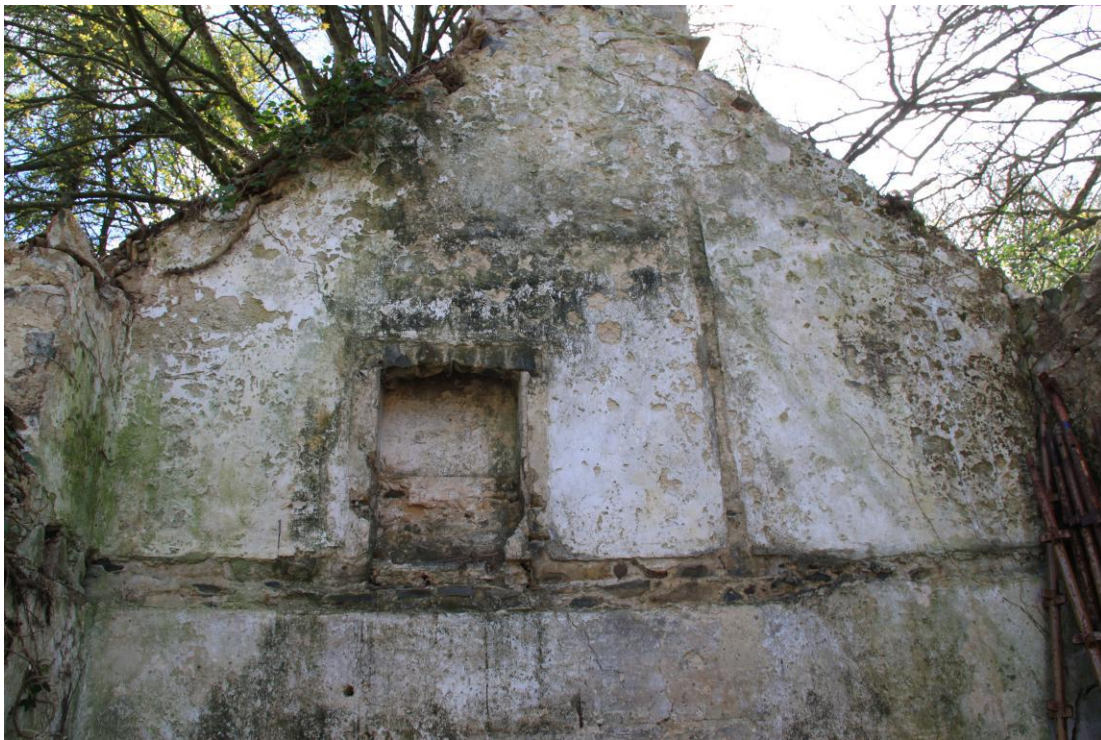
**Plate 25** - AD010-BR-025 - First floor fireplace, internal east wall, Former Coach House. N.B. Partition division mark to plaster.

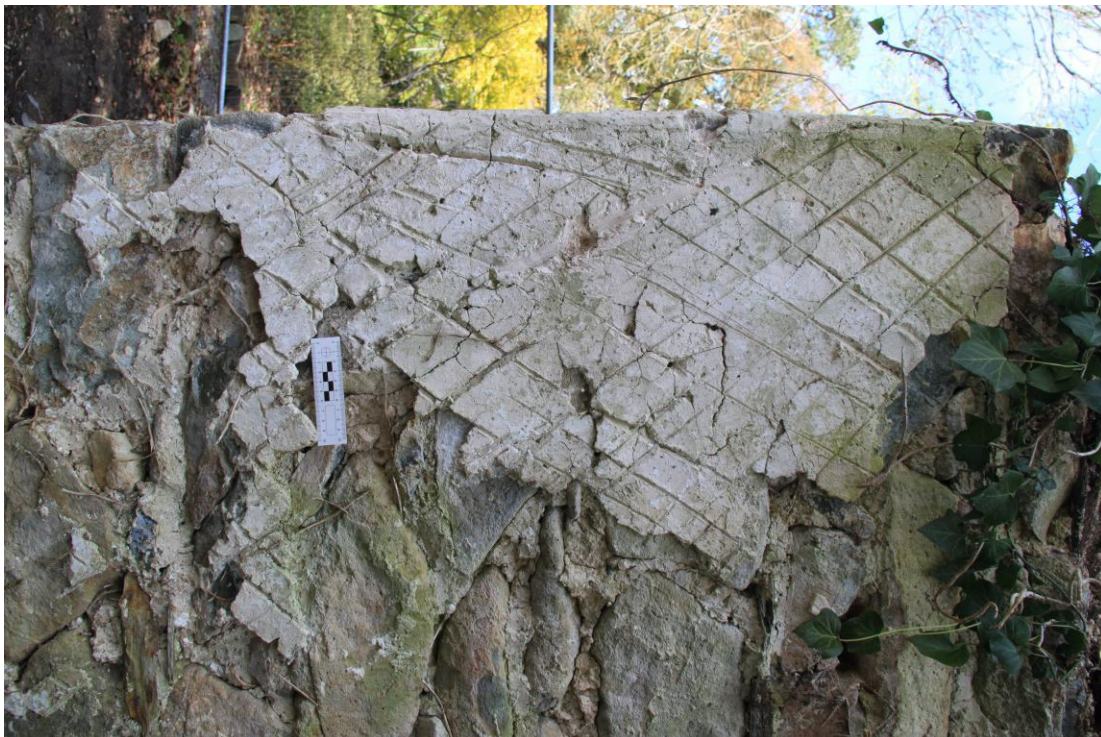
**Plate 26** - AD010-BR-026 - Scoring to plaster base coat, internal north wall, Former Coach House.

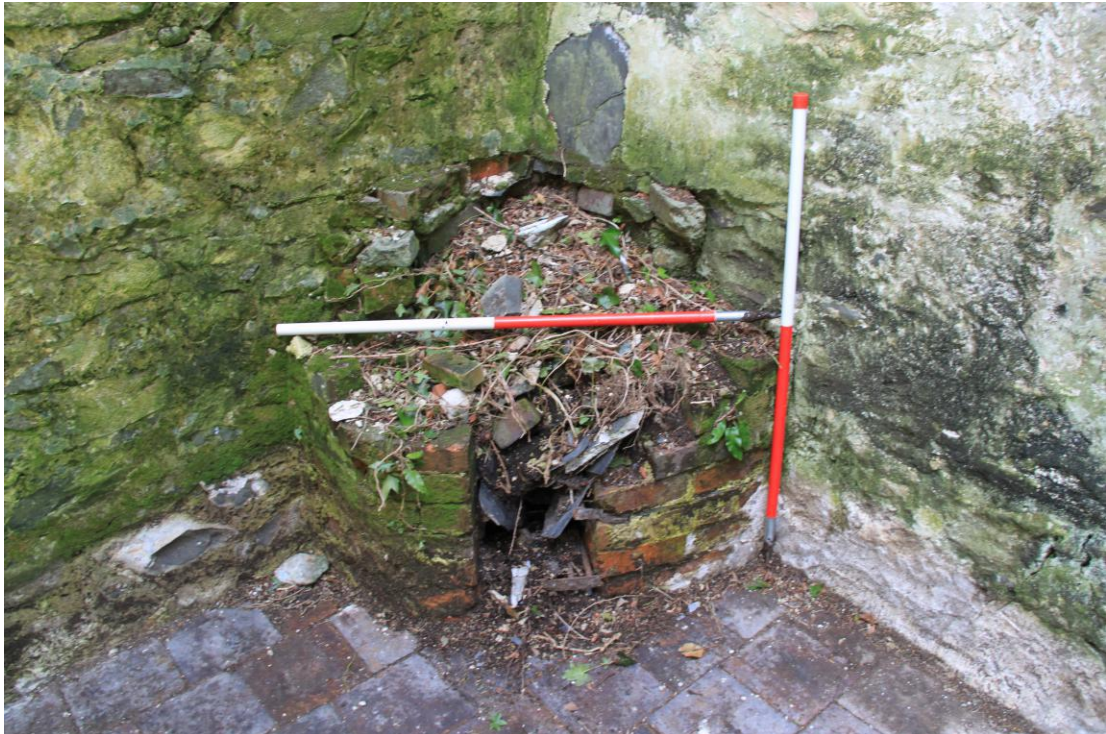
The remains of a small boiler occupies the north-east corner of the room (**Plate 38**) and red quarry tiles cover the floor (**Plate 37**). The two windows and door all have oak lintels internally (**Plates 39-40**). A four light sash window frame remains, but de-glazed and damaged in the east elevation (**Plate 47**).

**Plate 38** - AD010-BR-038 - Remains of small boiler/copper.

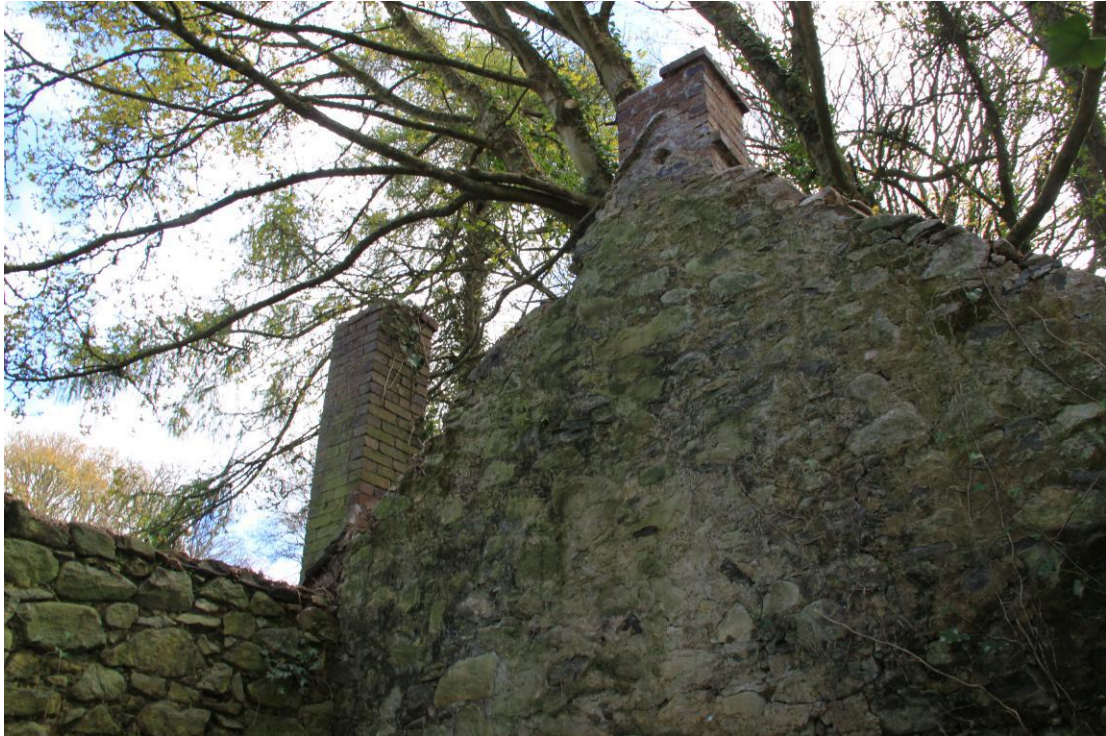
Joist sockets to the lateral walls (**Plate 42**) demonstrate the former existence of a loft. The east gable rises to a red brick stack with drip stones (**Plate 41**), at the apex a ridge purlin socket can be seen (**Plate 41**). The opposing gable shows, shared in common with the Coach House, there were four purlins, with additional weather protection above in the form of drip stones (**Plate 44**).

**Plate 41** - AD010-BR-041 - Internal view of Extension B towards the east, showing chimney stacks.

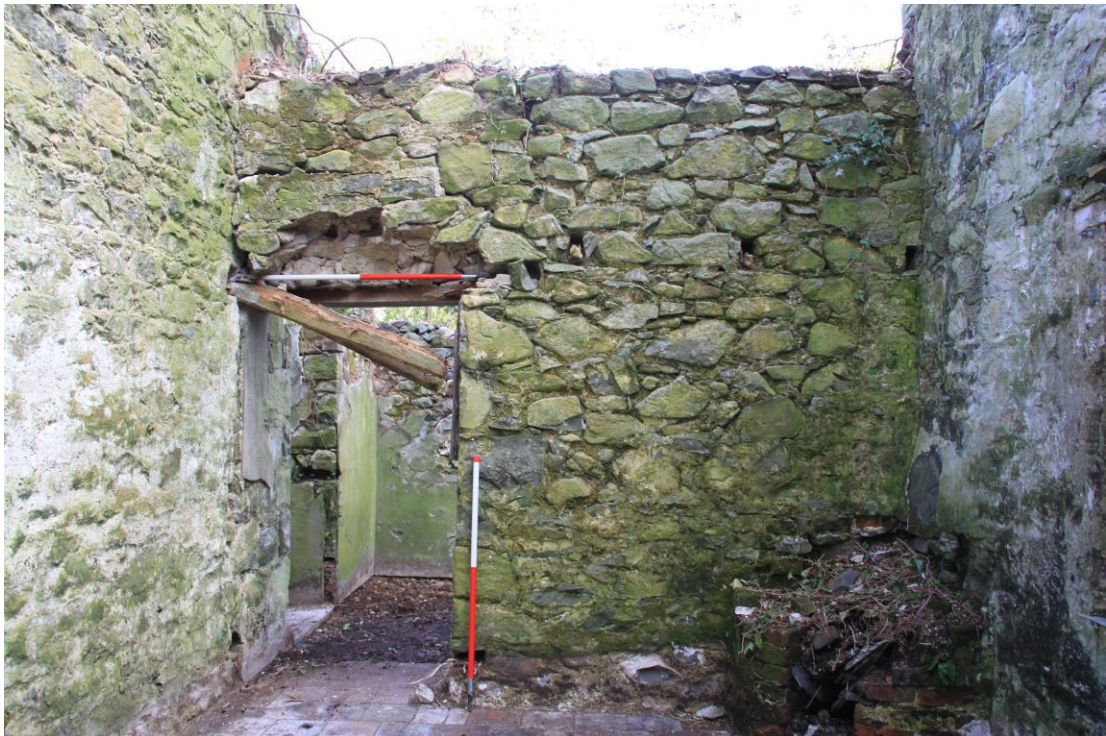
**Plate 42** - AD010-BR-042 - Internal view of Extension B towards the north.

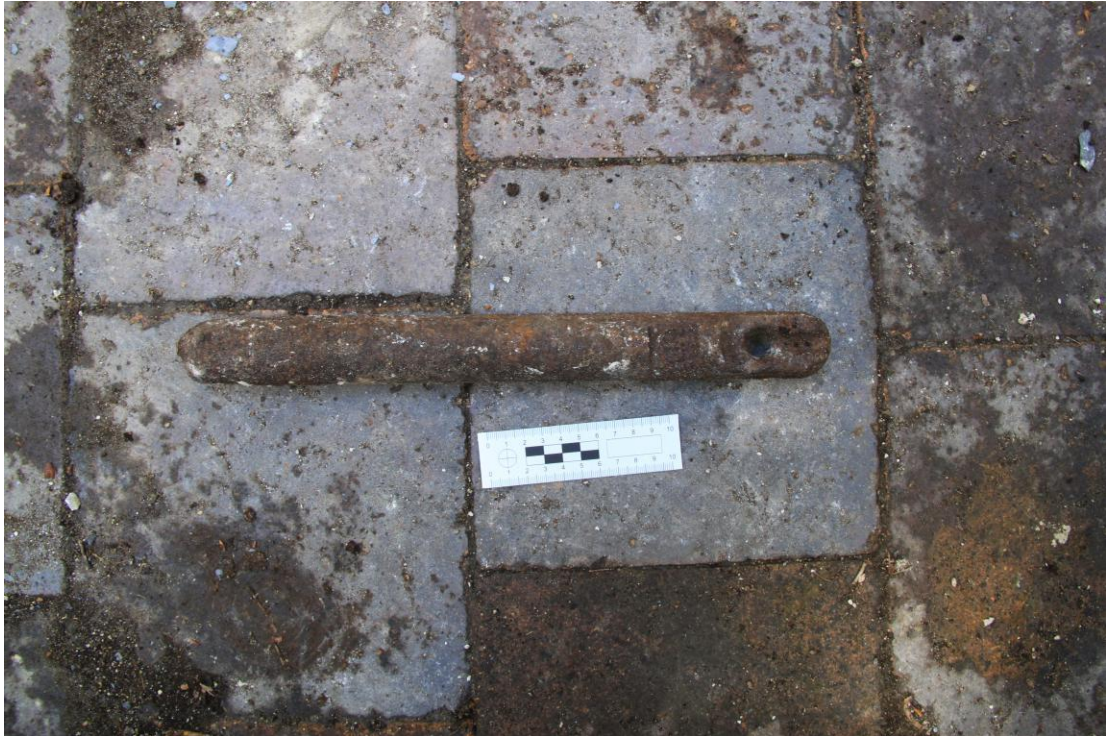
**Plate 43** - AD010-BR-043 - Sash weight found in Extension A.

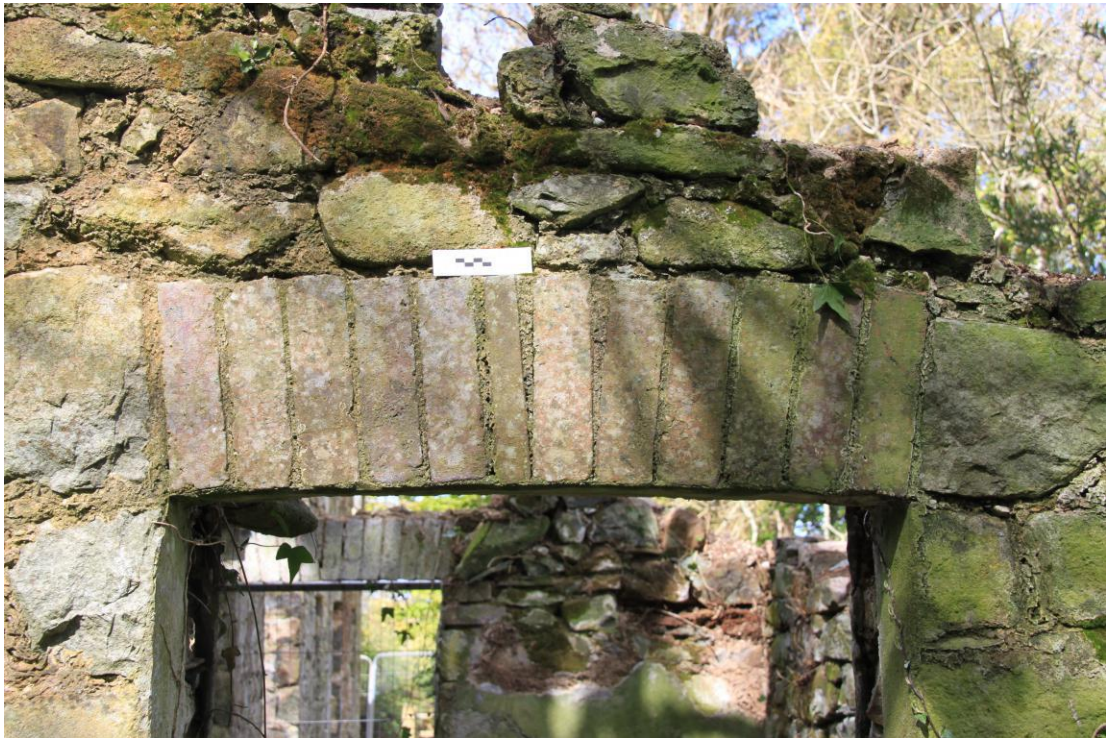
**Plate 45** - AD010-BR-045 - Brick flat segmental arch window head, Extension B East elevation.

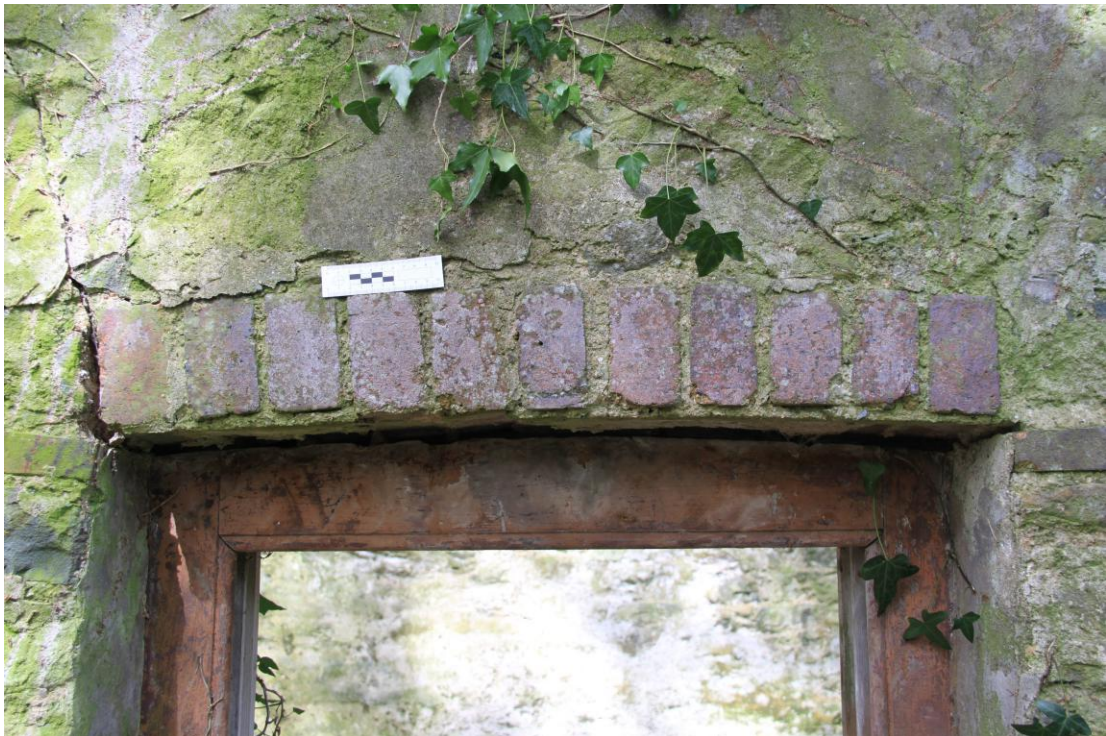
**Plate 46** - AD010-BR-046 - Brick flat segmental arch window head, Extension A east elevation.

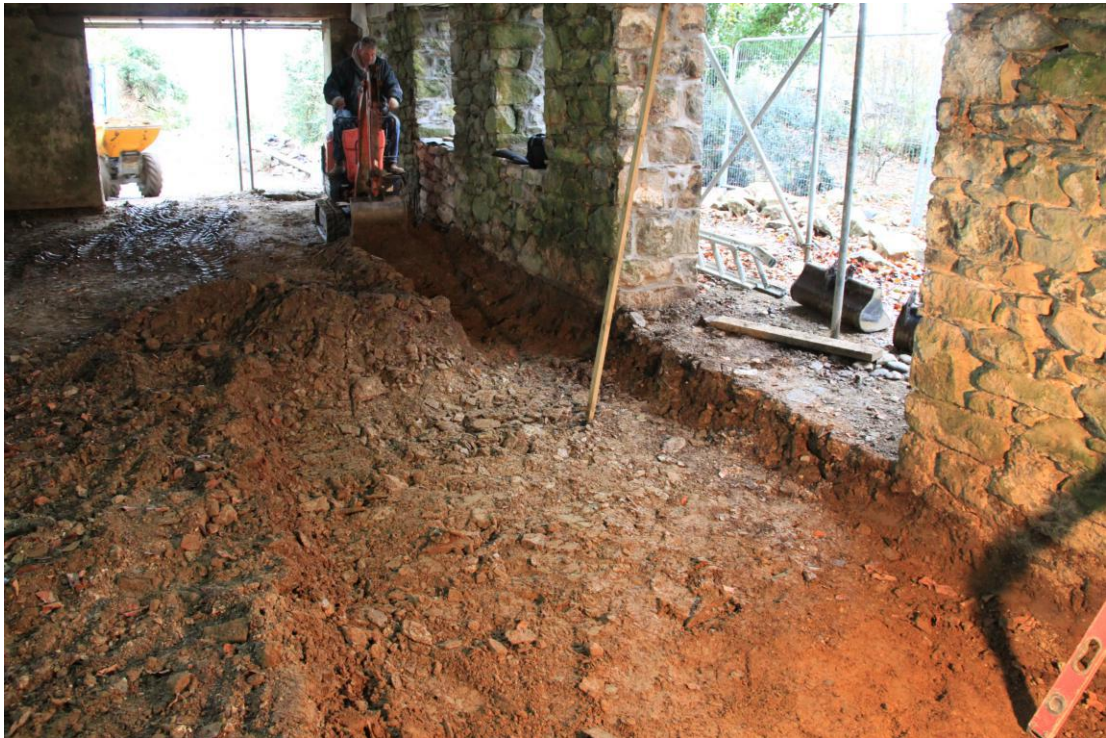
**Plate 48** - AD010-D1-001 - Internal excavations for poring of concrete slab, view north-west.

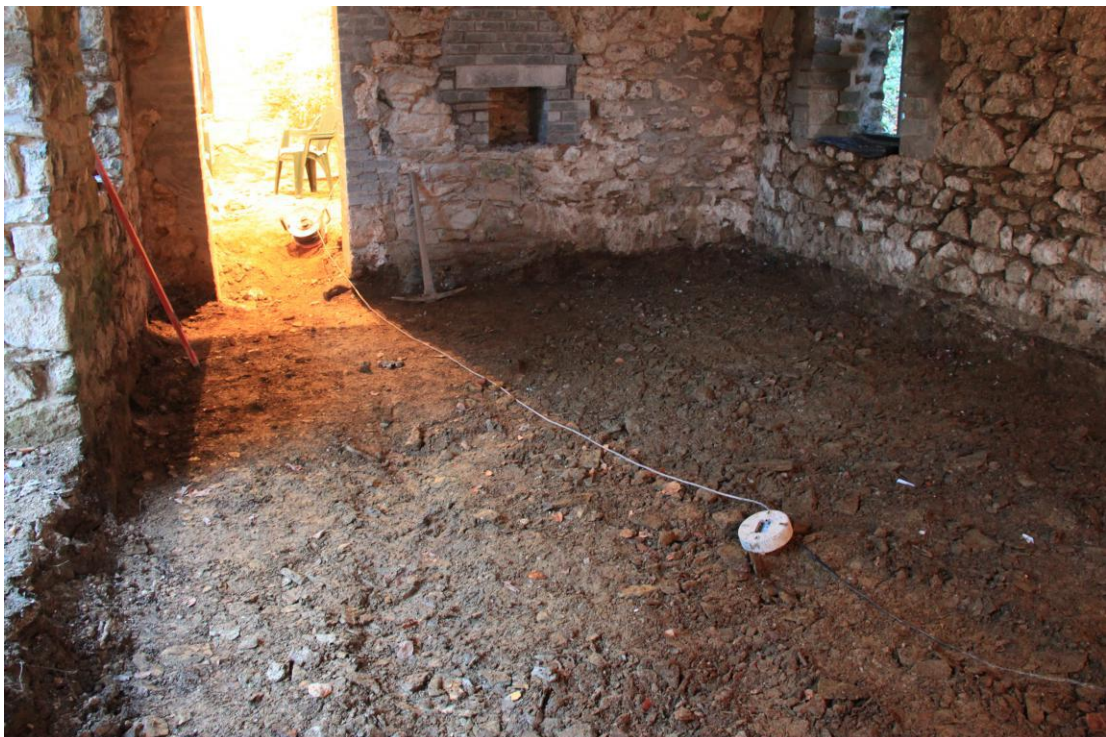
**Plate 49** - AD010-D1-002 - Internal excavations for poring of concrete slab, view east.

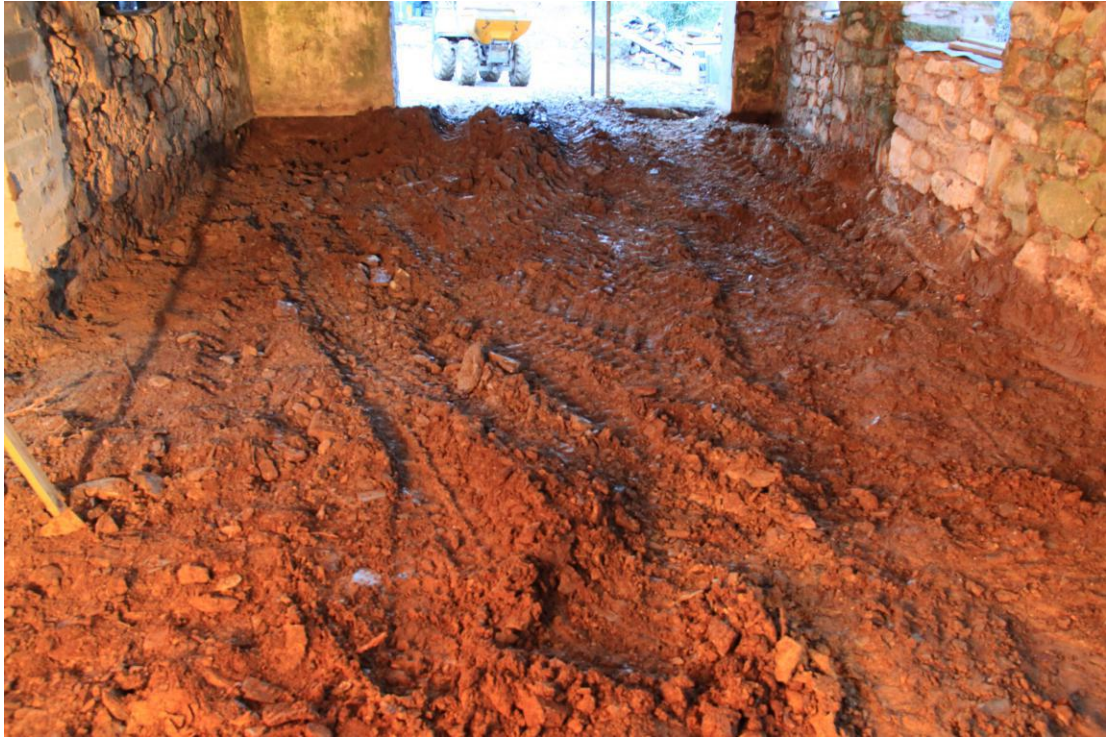
**Plate 50** - AD010-D1-003 - Internal excavations for poring of concrete slab, view west.

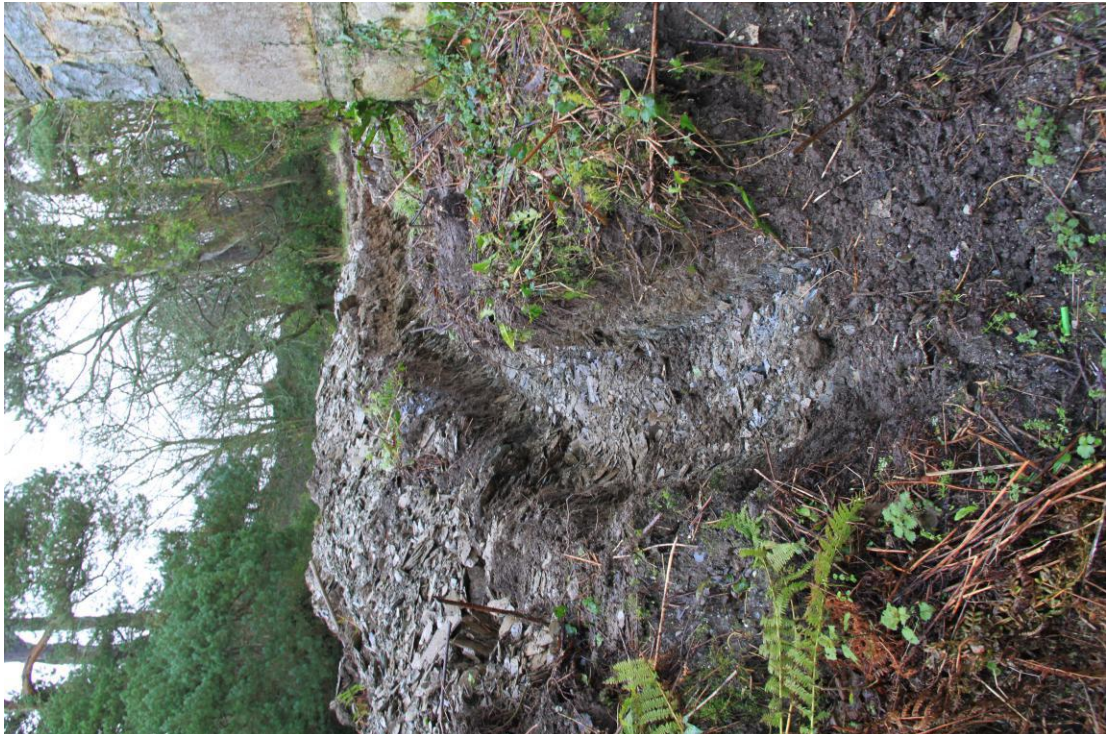
**Plate 51** - AD010-D1-004 - Service trench 1 starting at Castle Mill, view south-east.

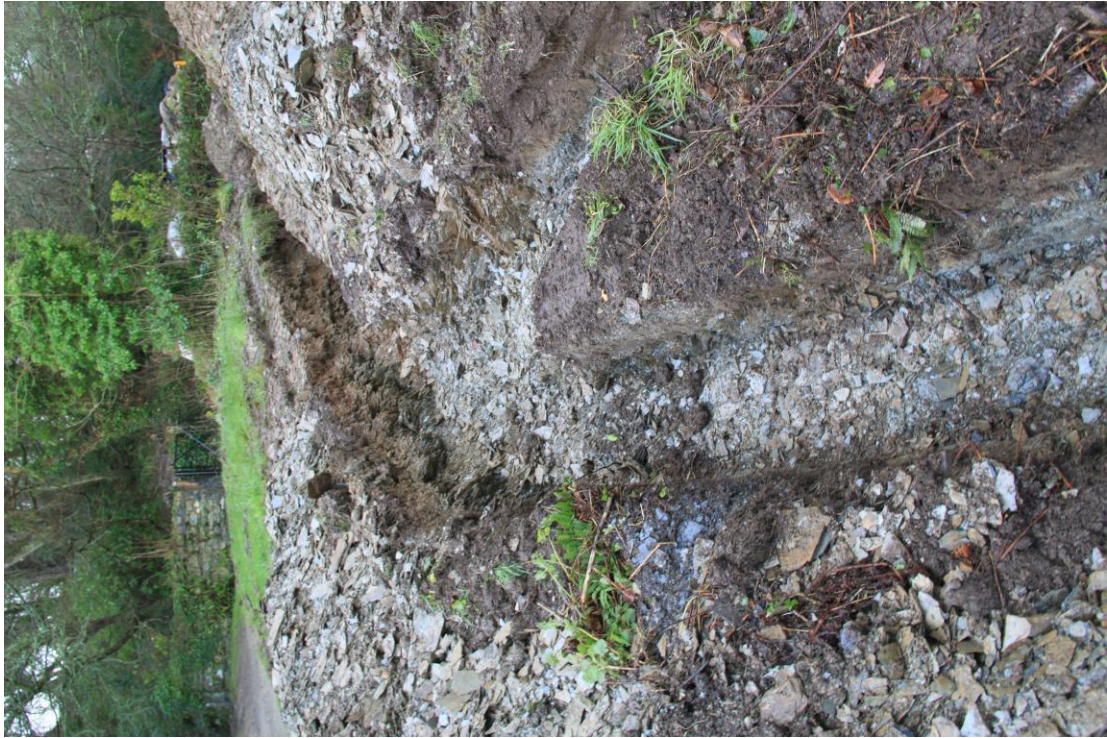
**Plate 52** - AD010-D1-005 - Service trench 1 passing Castle Mill.

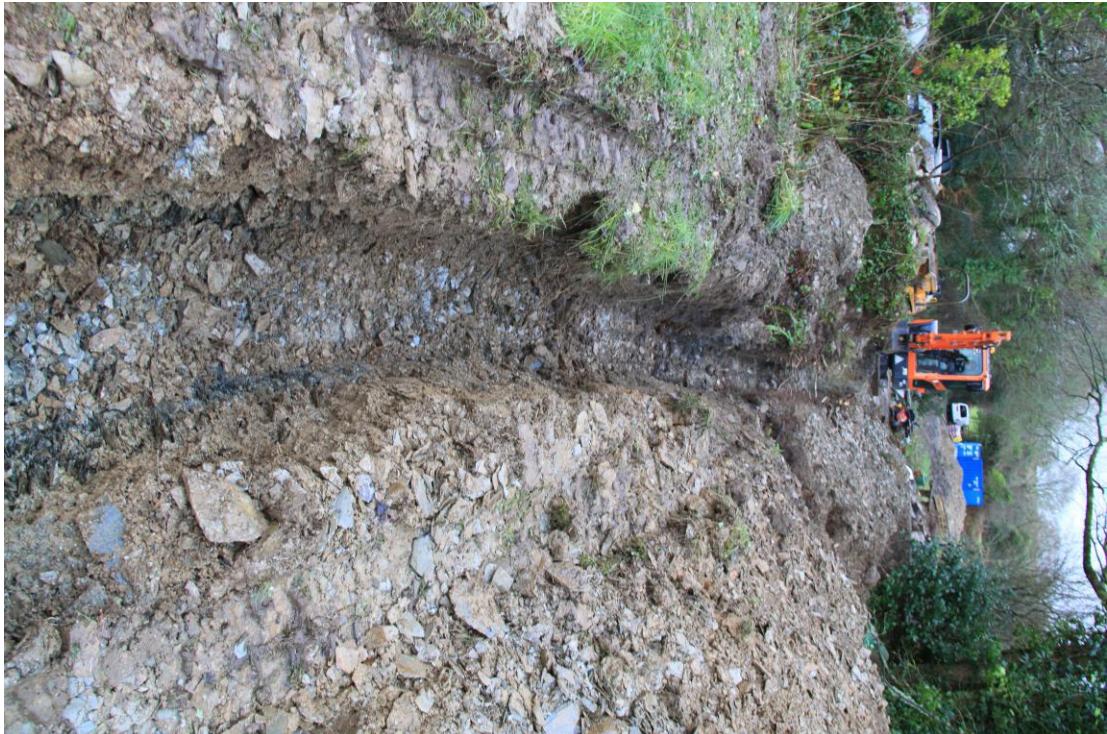
**Plate 53** - AD010-D1-006 - Service trench 1 passing Castle Mill.

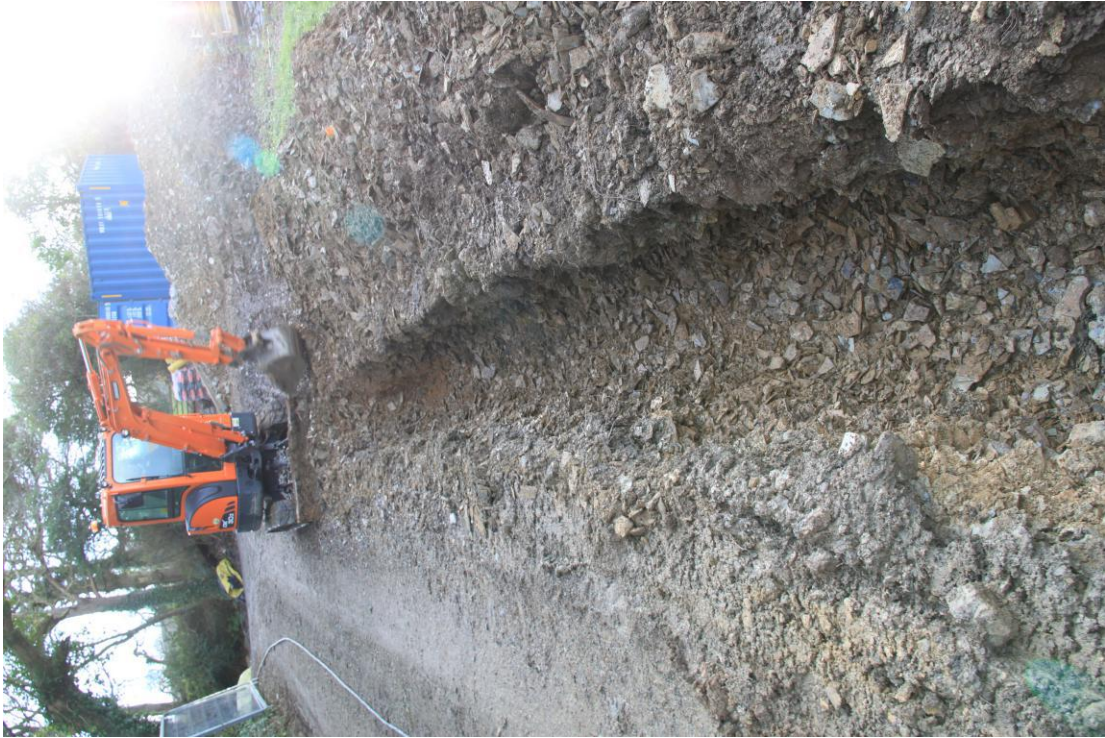
**Plate 54** - AD010-D1-007 - Service trench 1 at half way along track.

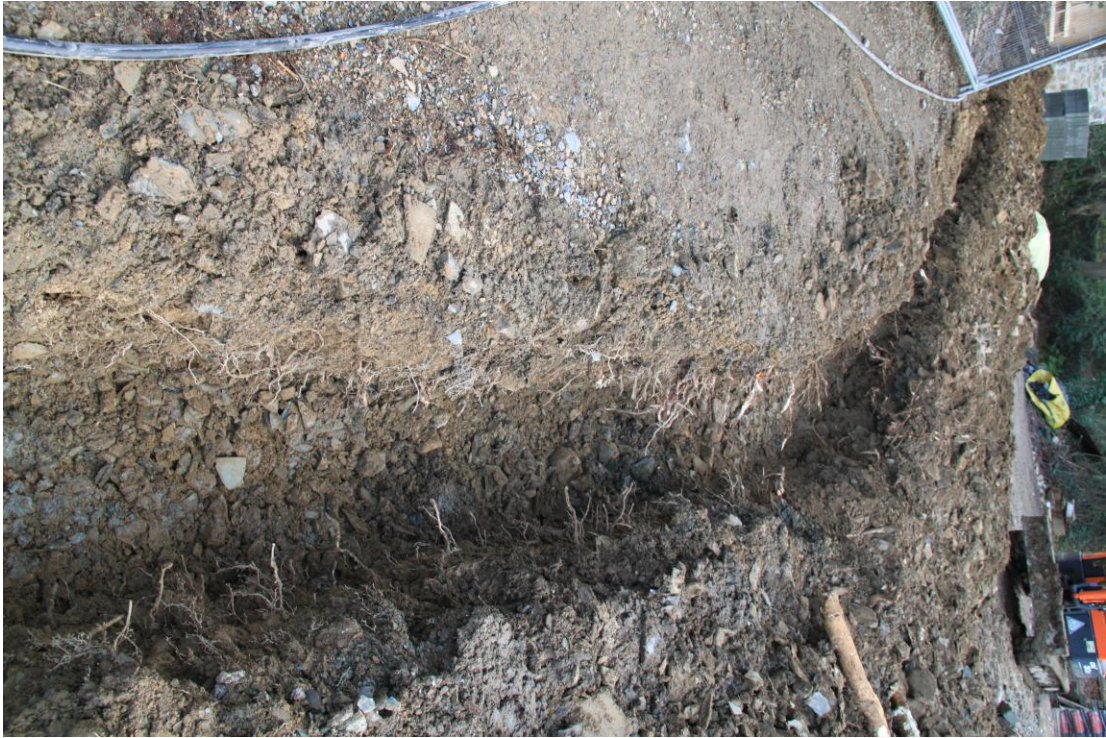
**Plate 56** - AD010-D1-009 - Service trench 1 at top of bank and returning back towards the Former Coach House.

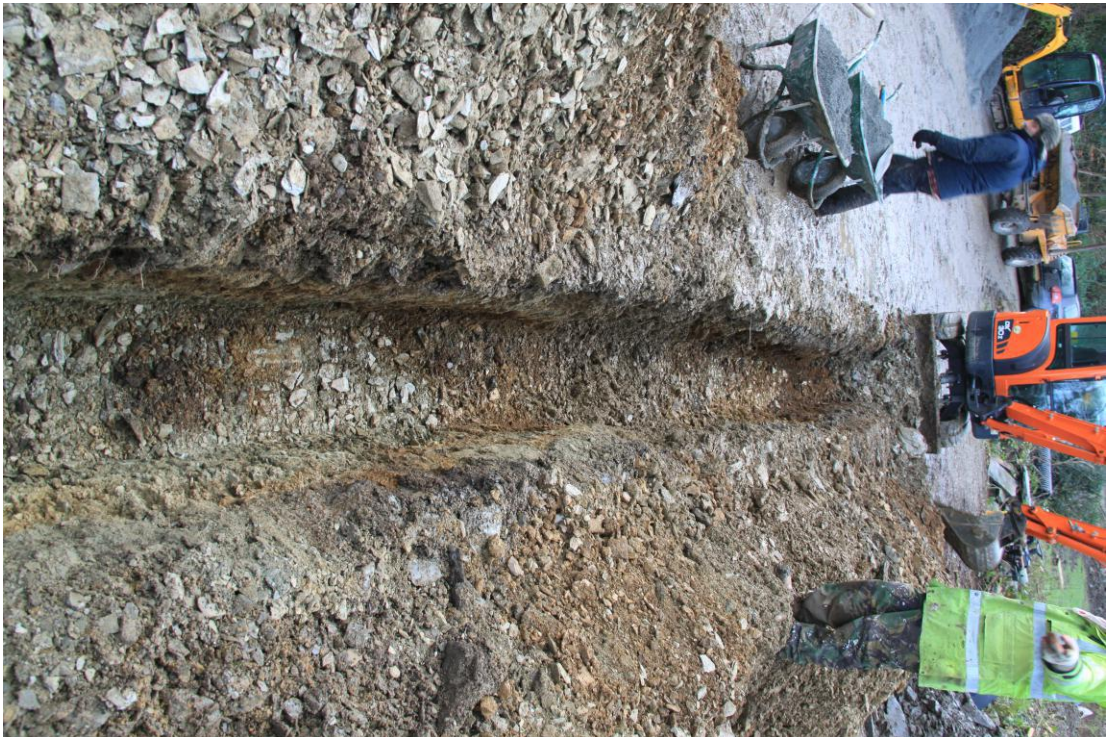
**Plate 57** - AD010-D1-010 - Service trench 1 at west end of Former Coach House.

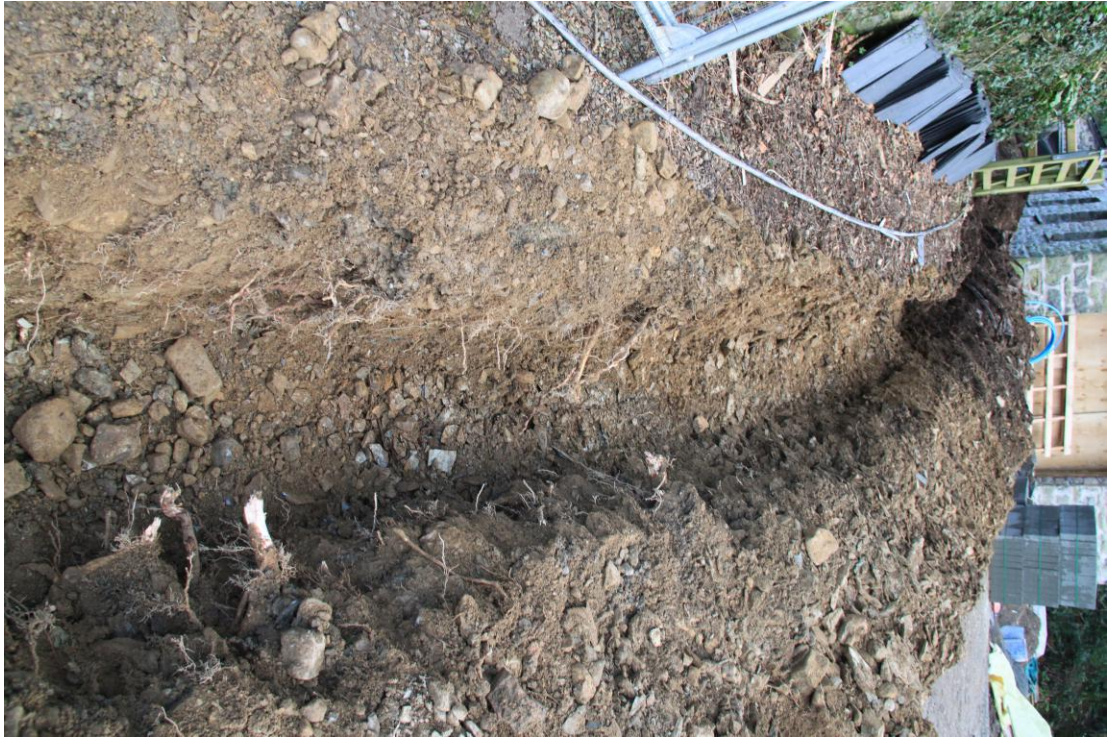
**Plate 58** - AD010-D2-011 - Service trench 1 at west end of Former Coach House

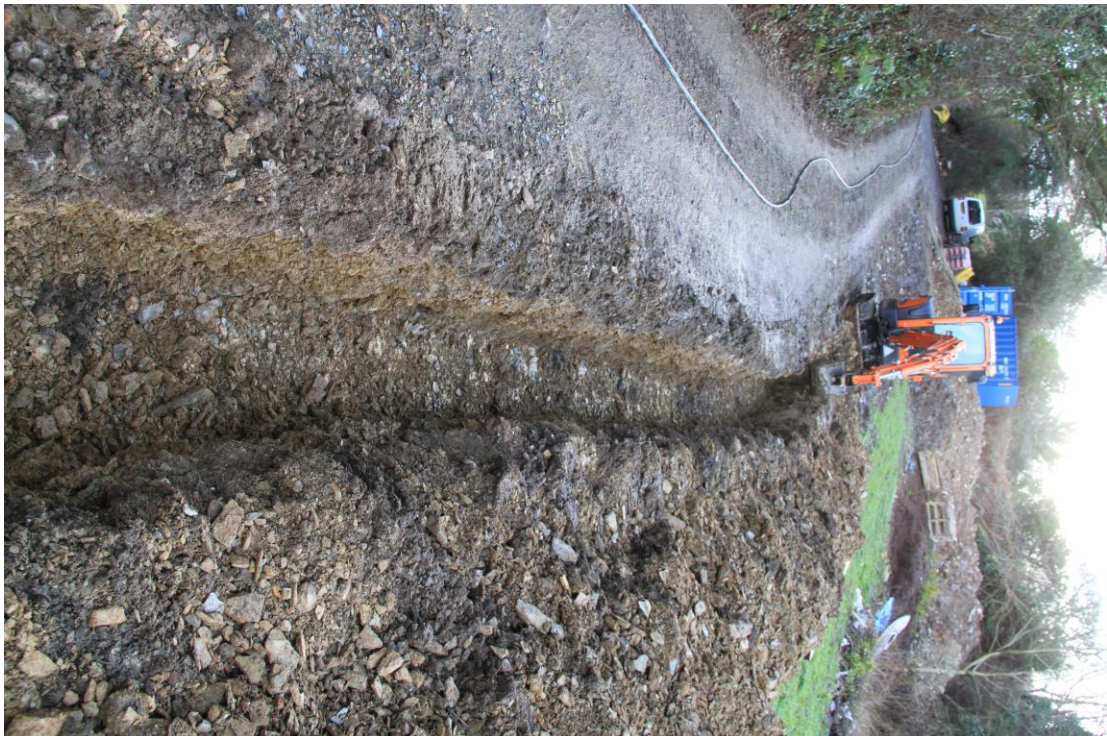
**Plate 59** - AD010-D2-012 - Service trench 1 extending along track.

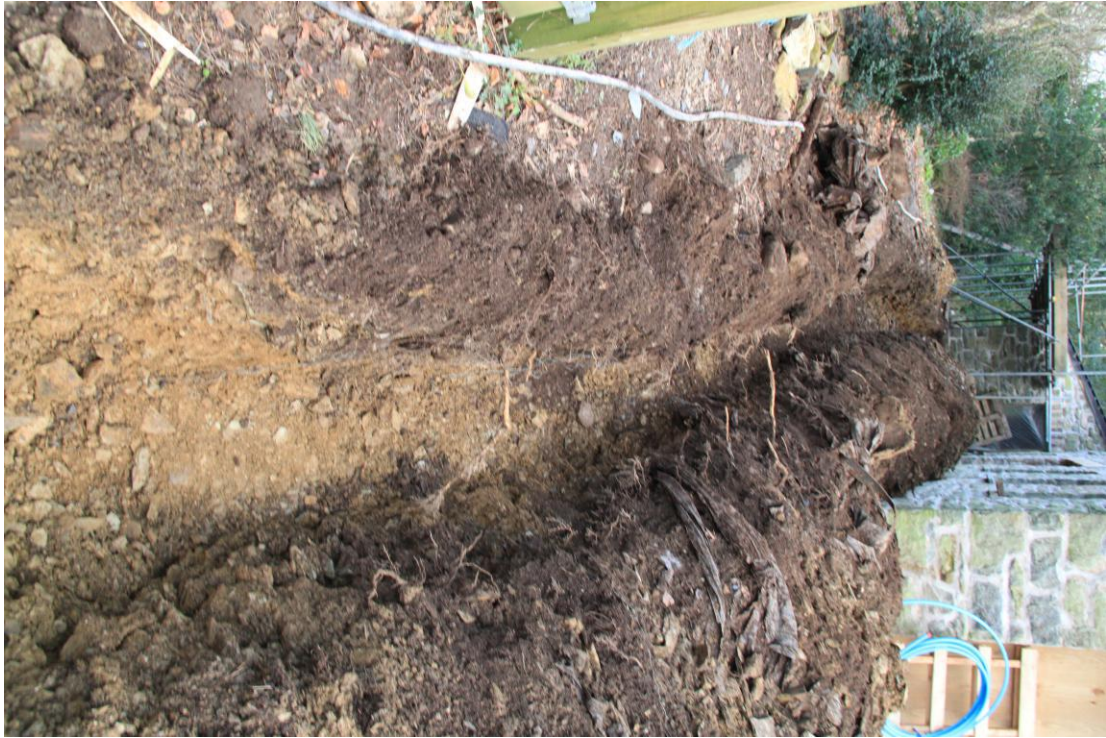
**Plate 60** - AD010-D2-013 - Service trench 1 returning along front of Former Coach House.

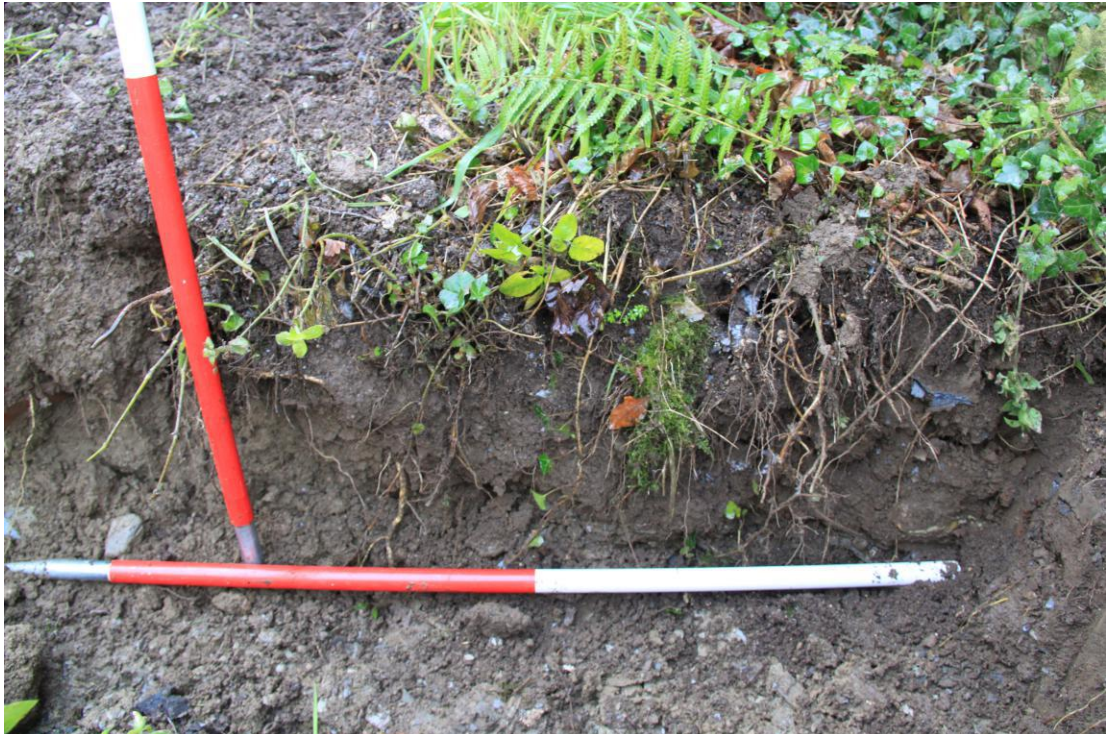
**Plate 61** - AD010-D2-014 - Section of service trench 1 next to Castle Mill.

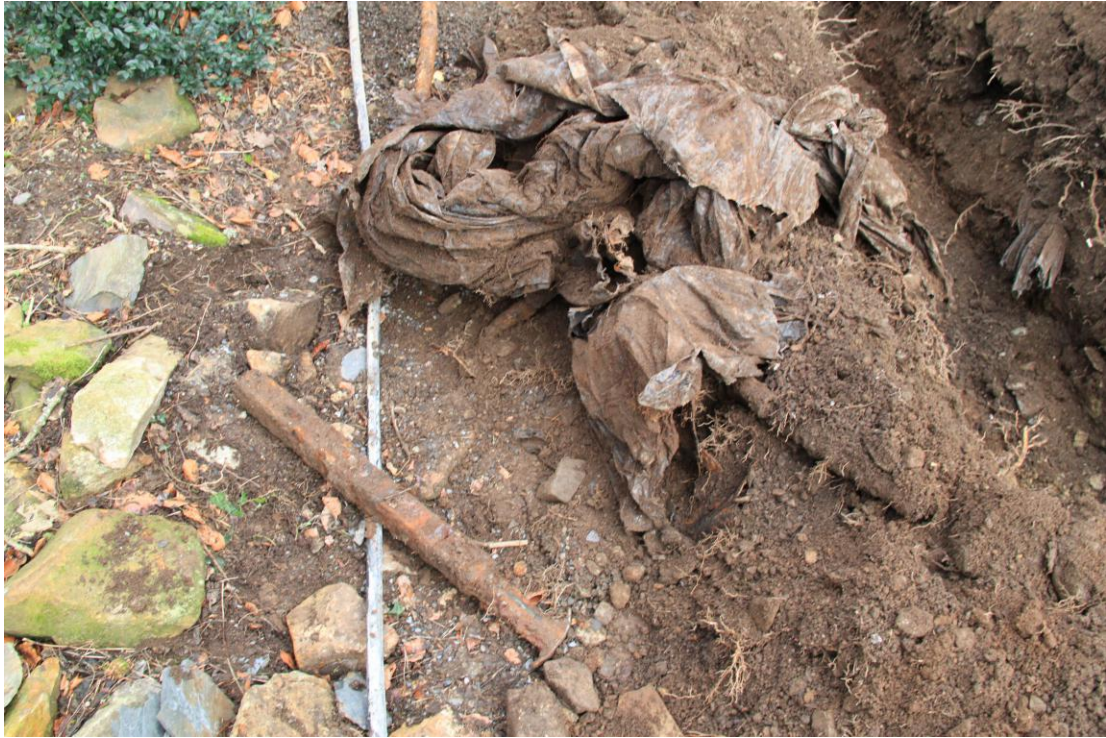
**Plate 64** - AD010-D2-017 - Plastic and metal recovered.

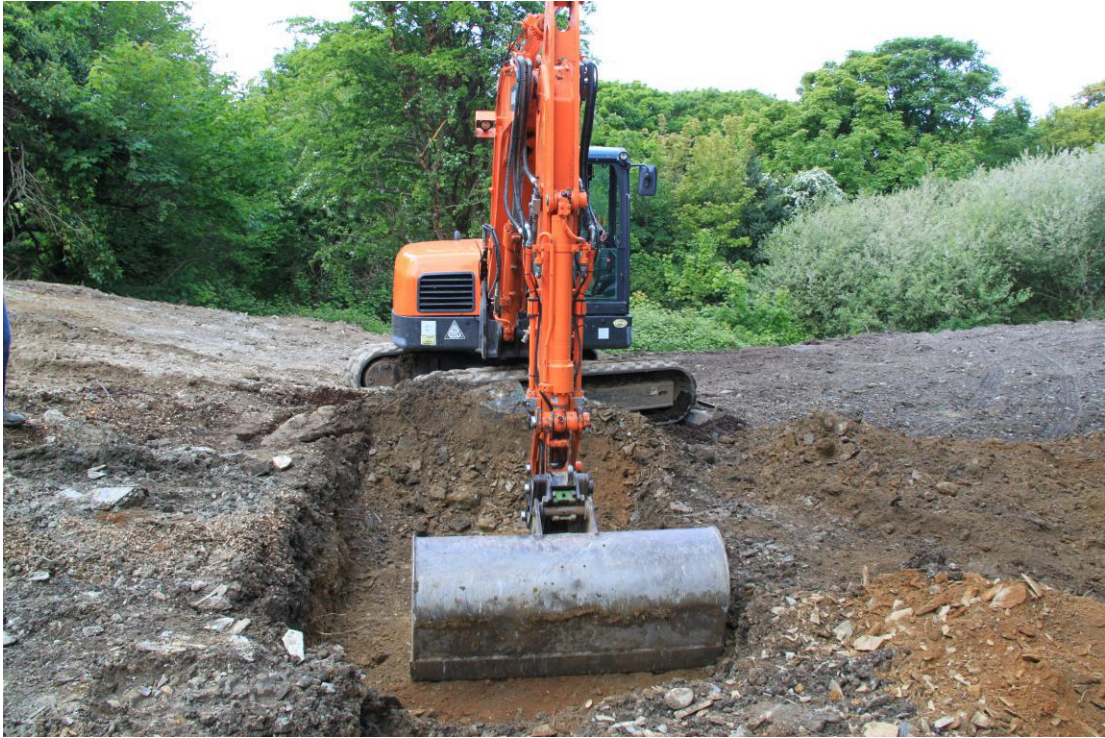
**Plate 66** - AD010-D3-019 - Excavation of septic tank pit.

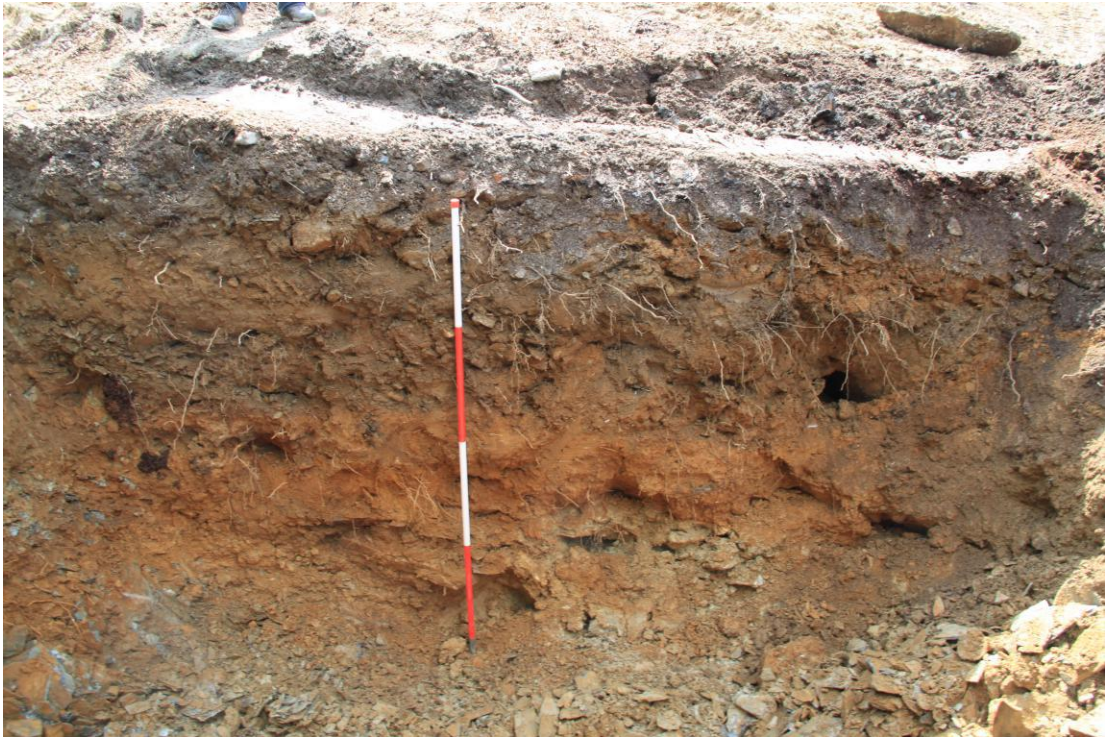
**Plate 67** - AD010-D3-020 - North section of septic tank pit.

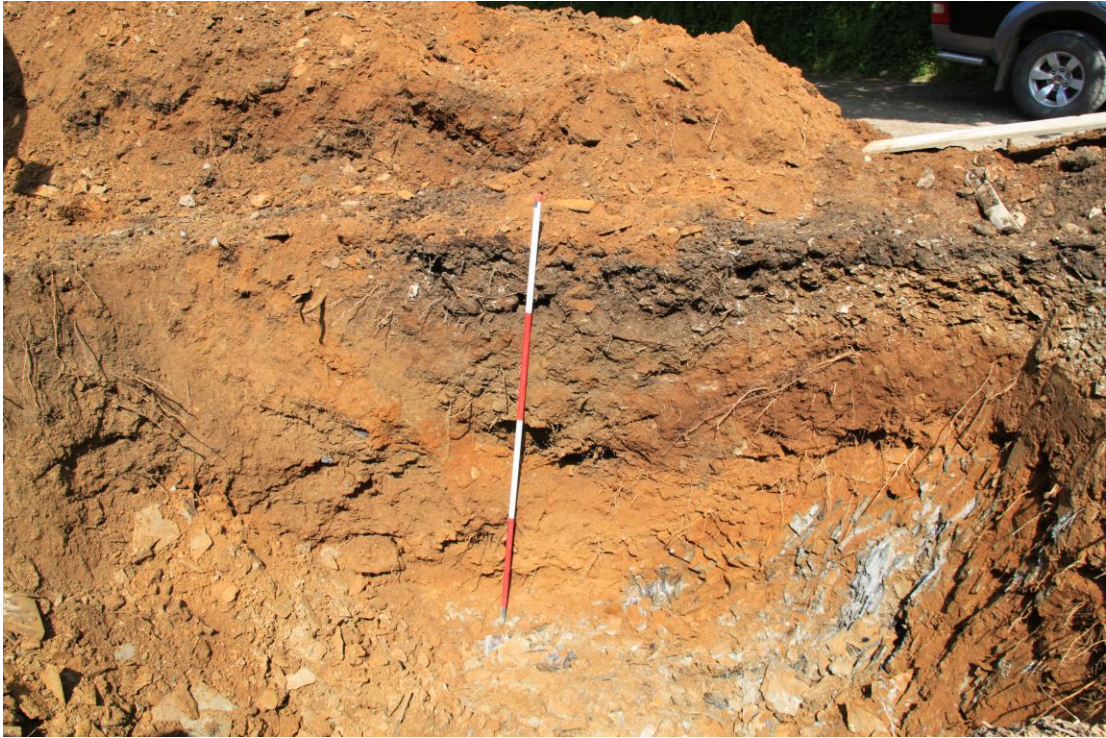
**Plate 68** - AD010-D3-021 - South section of septic tank pit.

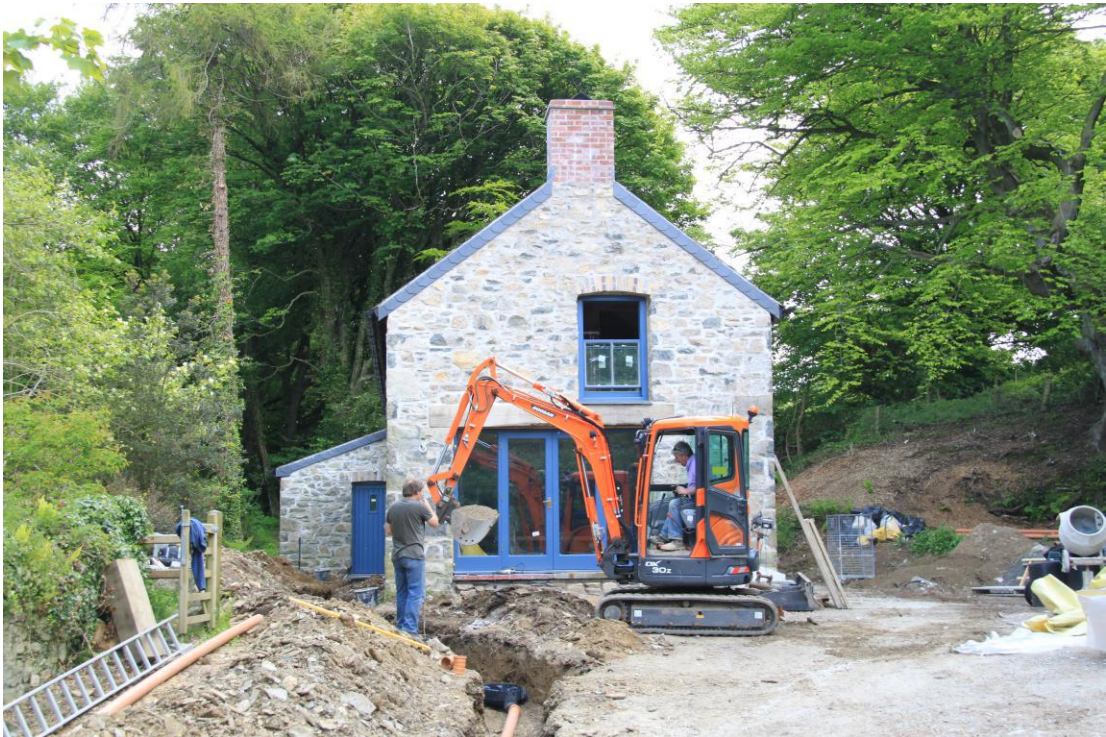
**Plate 69** - AD010-D3-022 - View towards Former Coach House showing location of service trench 2.
