# Former Coach House, Newport, Pembrokeshire

## Archaeological Buildings Record & Watching Brief Report

Planning #: **NP/14/0534**

Project #: AD010      25<sup>th</sup> May 2016

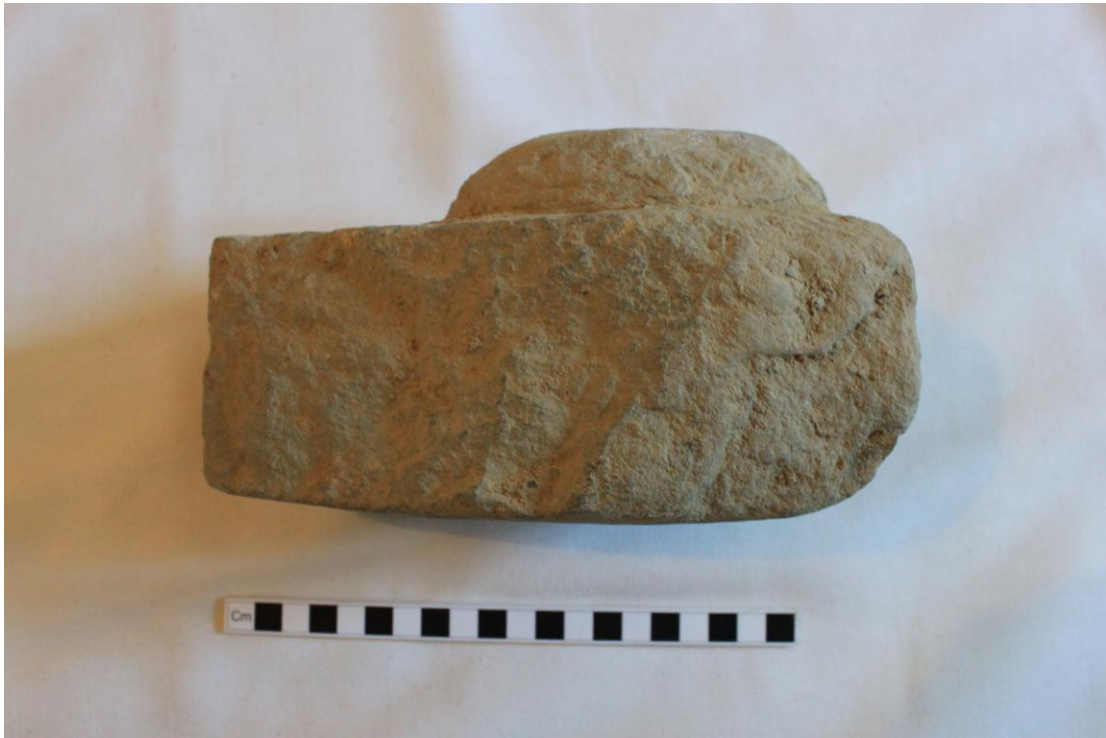
**Plate 70** - AD010-FN001-1 - Unfinished carved stone, recovered Day 3.

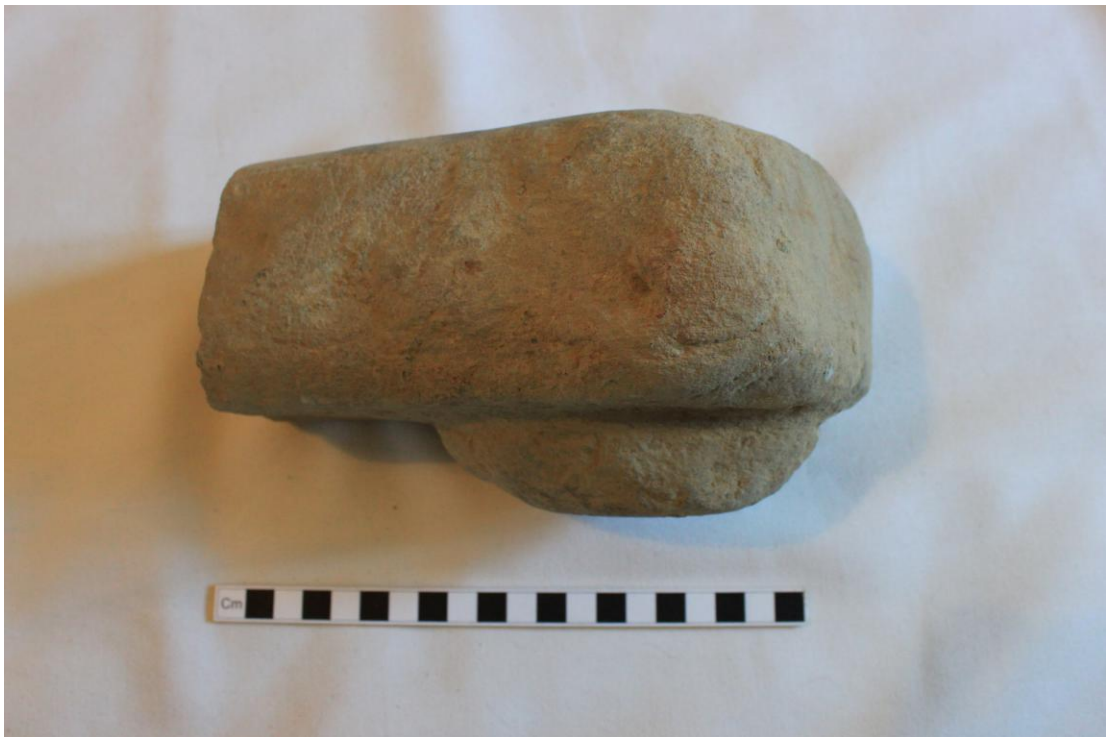
**Plate 71** - AD010-FN001-2 - Unfinished carved stone, recovered Day 3.

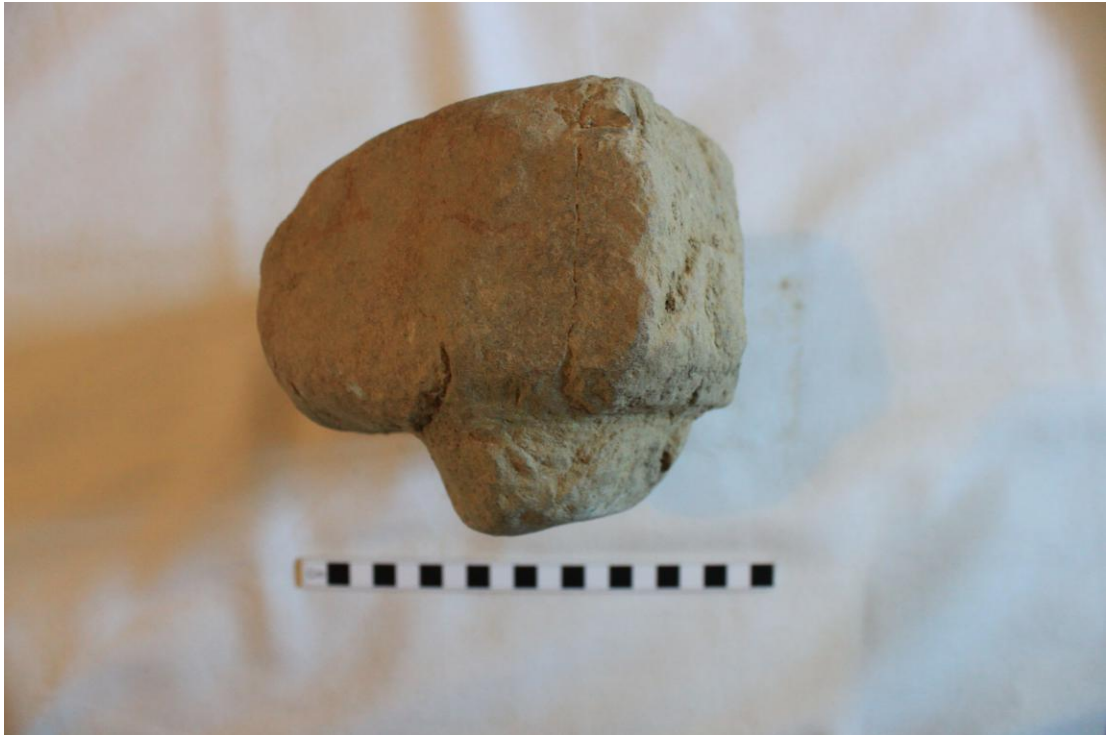
**Plate 72** - AD010-FN001-3 - Unfinished carved stone, recovered Day 3.

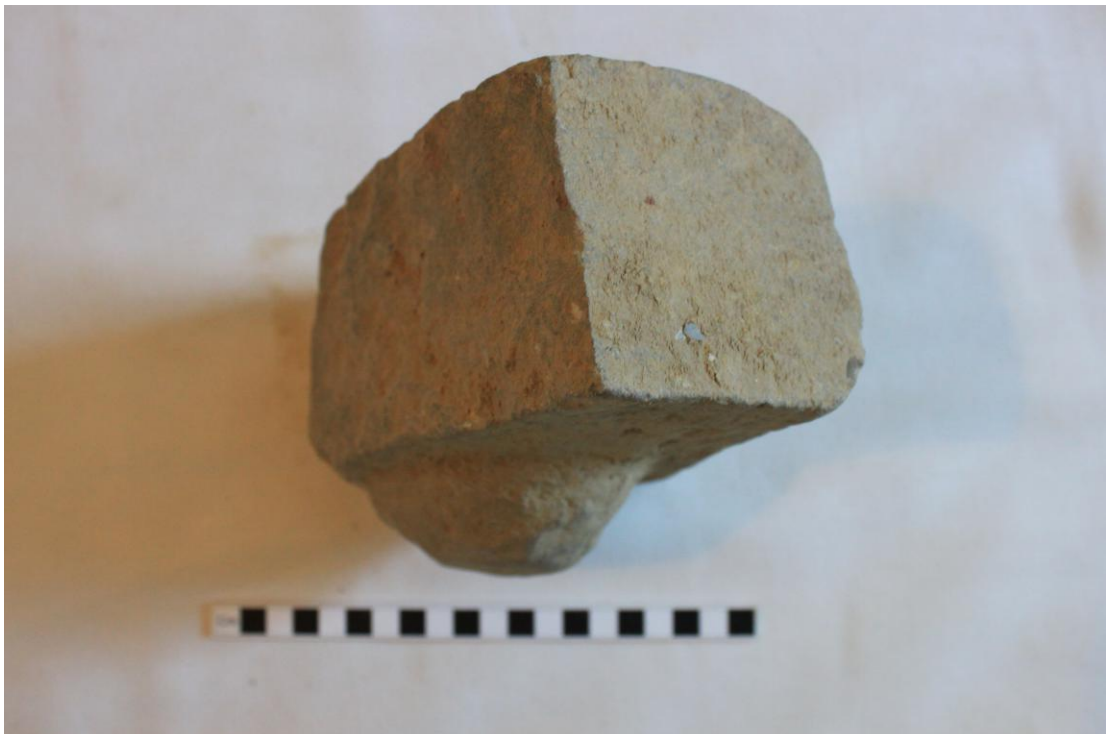
**Plate 73** - AD010-FN001-4 - Unfinished carved stone, recovered Day 3.

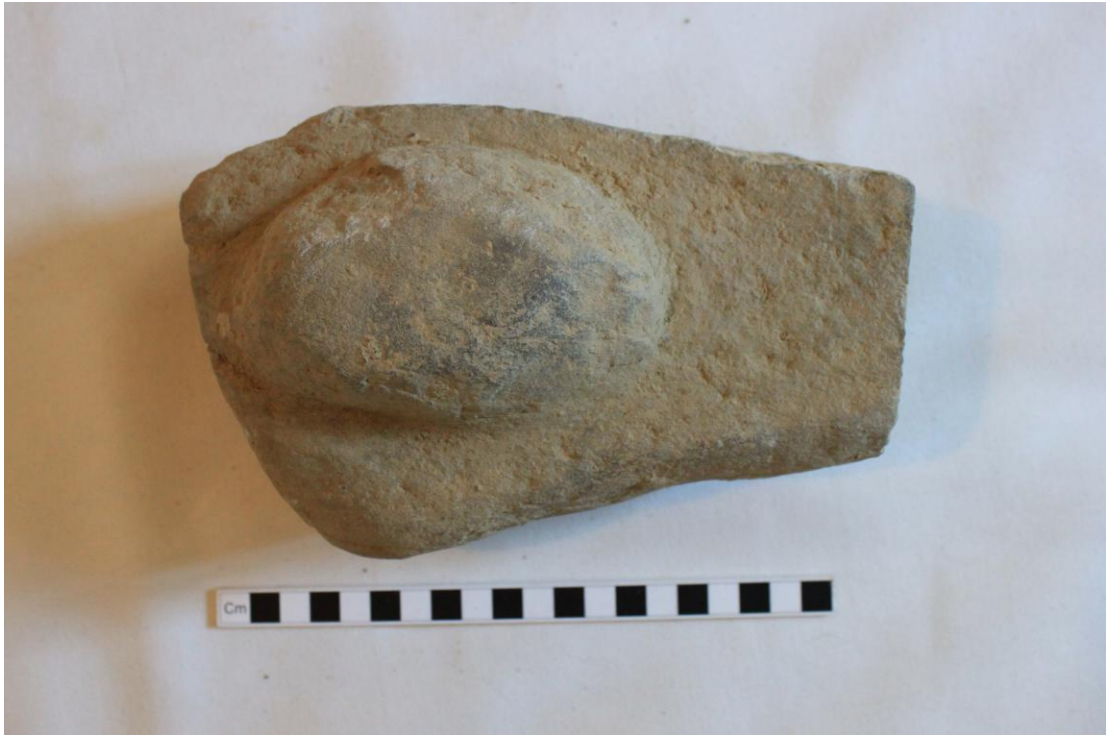
**Plate 74** - AD010-FN001-5 - Unfinished carved stone, recovered Day 3.

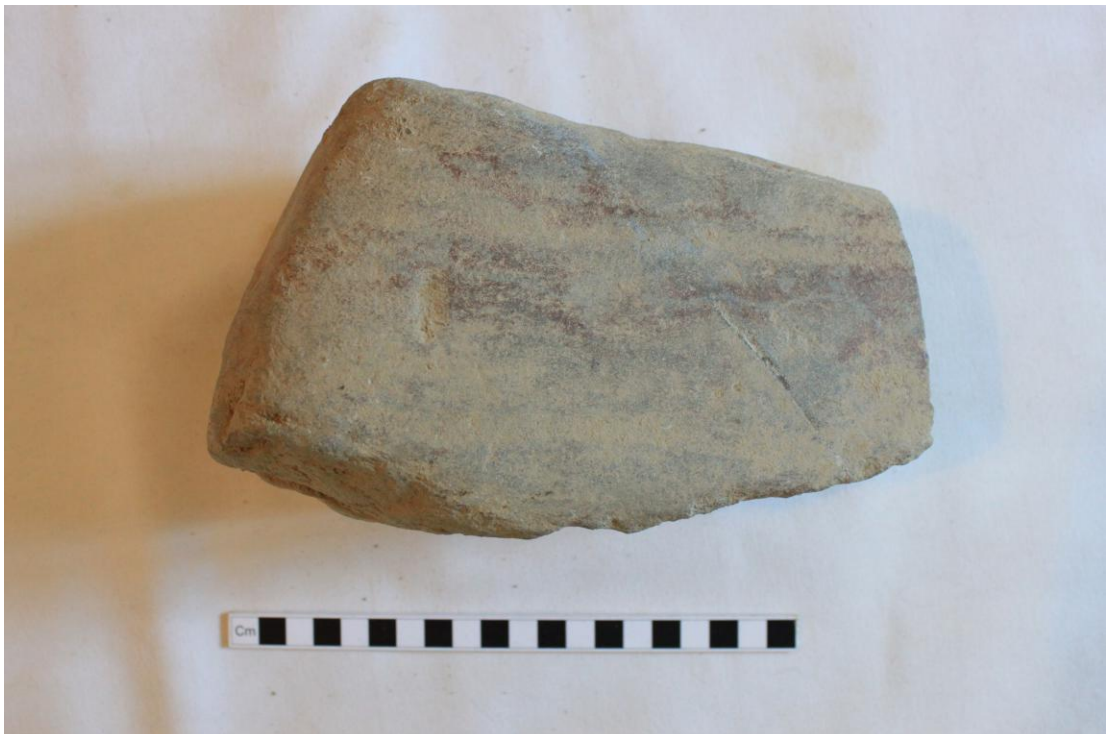
**Plate 75** - AD010-FN001-6 - Unfinished carved stone, recovered Day 3.
